## DUAL CAB CENTRAL LOCKING CANOPY

### Ascent Canopy AC20C – Toyota Hilux

(2026+ Vehicle Production Onwards)

**FITTING KIT: TAILGATE AND HEADBOARD KIT 6178585. TUB MOUNT KIT 6178583**

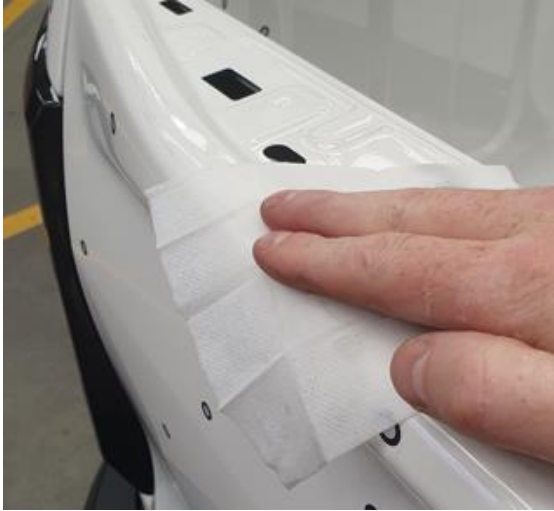
2.5) Clean the top leading edge of the tailgate with an alcohol wipe (602018) and allow it to dry. Use a primer stick (665044) along the top flat face **ONLY**, sparingly, without spillage and allow to dry.

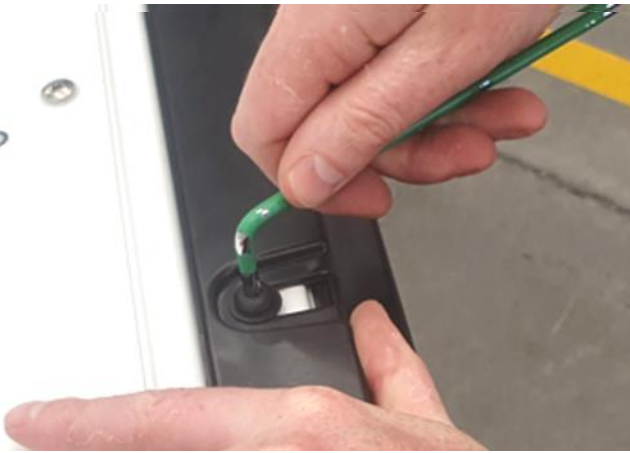
2.10) While pushing down on the new tailgate cap, with a T30 Trox drive, screw down tailgate stop using the original retained OE screws in six places. Hand-tighten, do not use an electric drill and do not overtighten to avoid stripping.

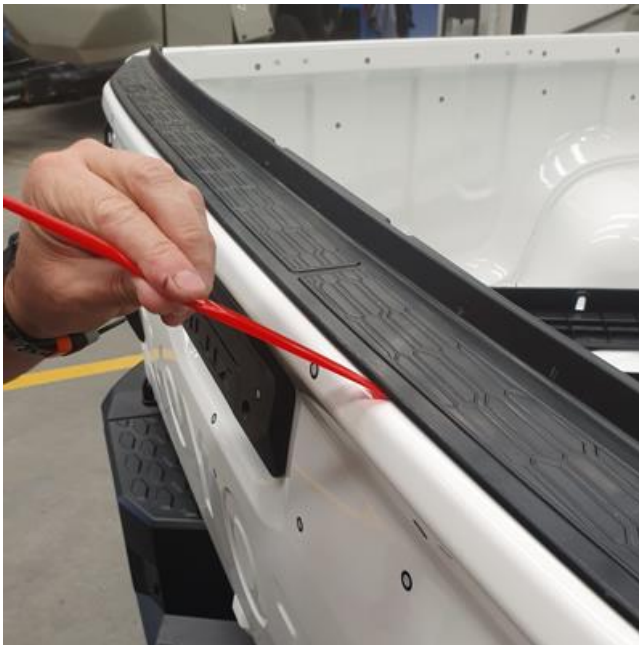
2.11) Close the tailgate and slowly pull out the remaining tape liner. Then push down all along taped edge to wet out tape to sheet metal.

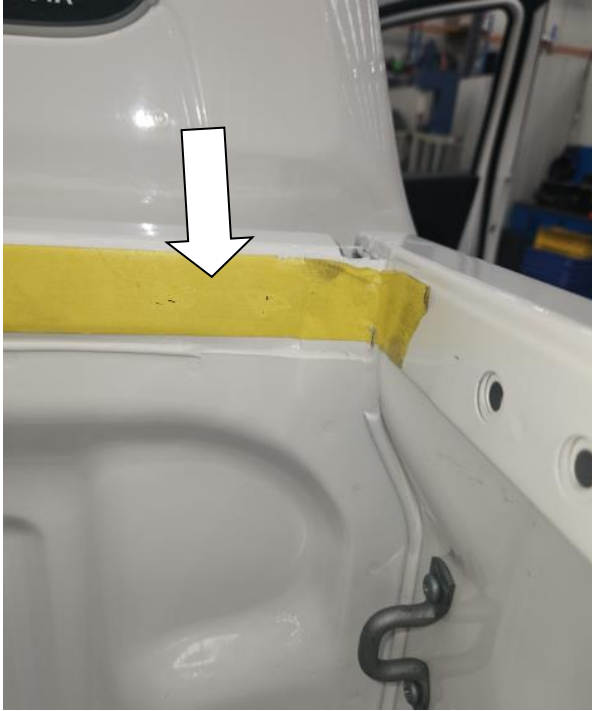
- 3.0) **For vehicles fitted with cabin guards ONLY that were removed in Section 1:**  
Apply masking tape across the front inner corners of the vehicle's tub to approximately 200mm inboard.

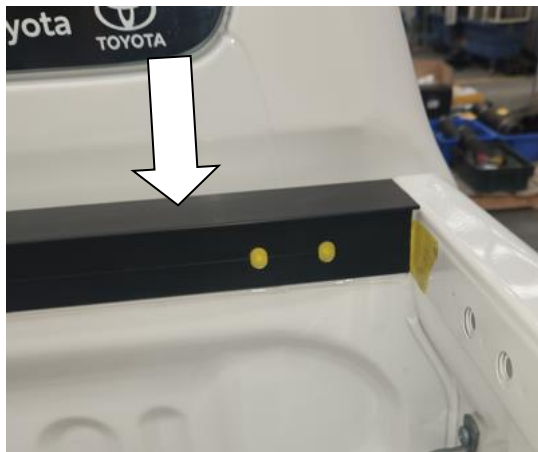
- 3.1) **For vehicles fitted with cabin guards ONLY that were removed in Section 1:**  
Place the front header rail bracket assembly (667AQ018) down on the front wall of the tub with the foam tape underneath the header rail pressed against the top of the front upper surface of the tub. Locate each end of the assembly **with even gaps to both sides of the tub.**

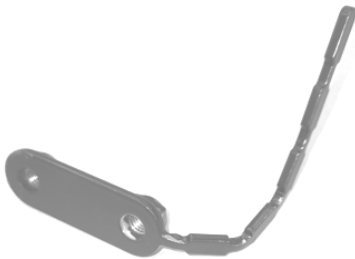
3.8) Fit between the cabin and the tub the nut plate (4655378) to align to the two holes in the corners of the tub. The end of the nut plate may be bent to a shape to provide access for fitment. Place masking tape on the back of the cabin before it is inserted to prevent scratching the cabin's paint work.

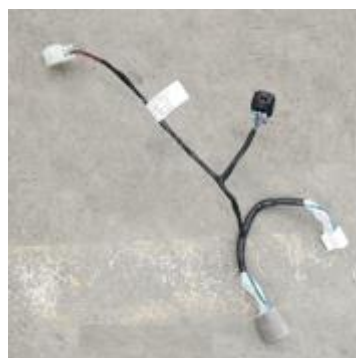
**Patch loom for  
connection  
behind LH front  
floor kick panel**

4.1) The vehicle electrical patch wiring loom (667PJ006) has two parts. The main patch loom and the patch loom to plug into the connectors behind the left-hand passenger front floor side kick panel.

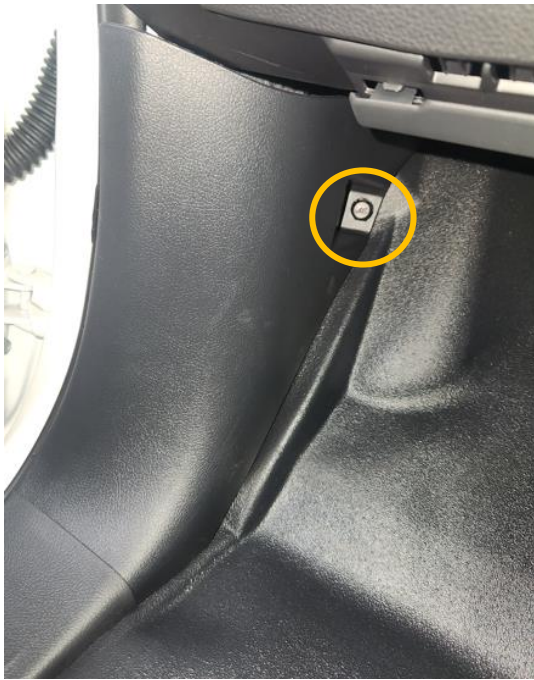
4.3) Undo the retaining nut on the left-hand passenger side front kick panel and pull the kick panel cover towards the foot well, to release the trim clips and expose the electrical connector block behind it.

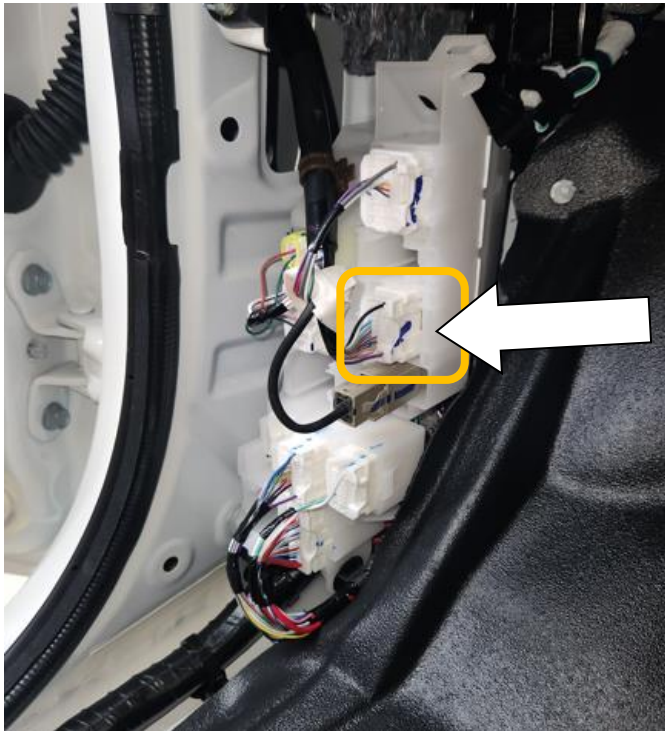
4.4) Locate the OEM connector in the middle and towards the inboard side of the connector block and unplug it.

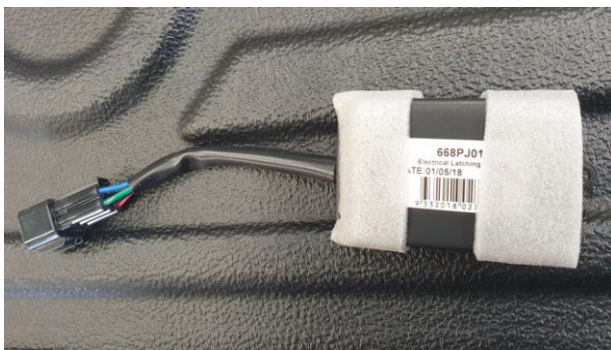
4.6) Use (668PB015) anti-rattle foam strips and apply in the two positions shown wrapped around (668PJ015) latch relay.

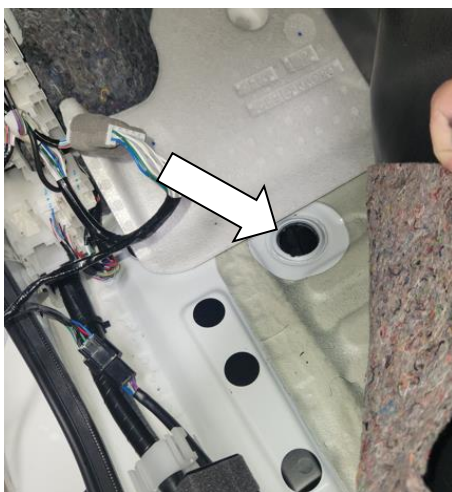
4.8) Lift the floor carpet in the front foot well and push out the floor grommet from the inside

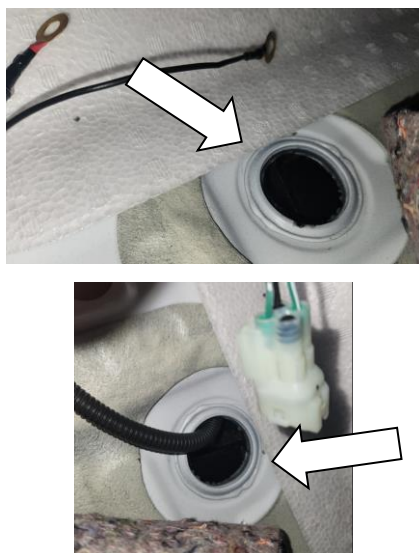
4.9) Thread the eye terminal end of the main patch loom (667PJ006) down through the hole in the floor and pull them through. Also do this with the white canopy connector on the main patch loom.

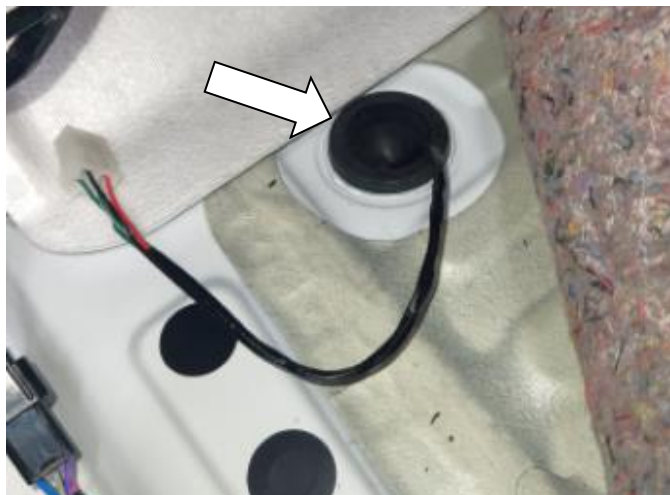
4.10) Seat the grommet on the loom into the hole in the footwell. Silicon seal around this.

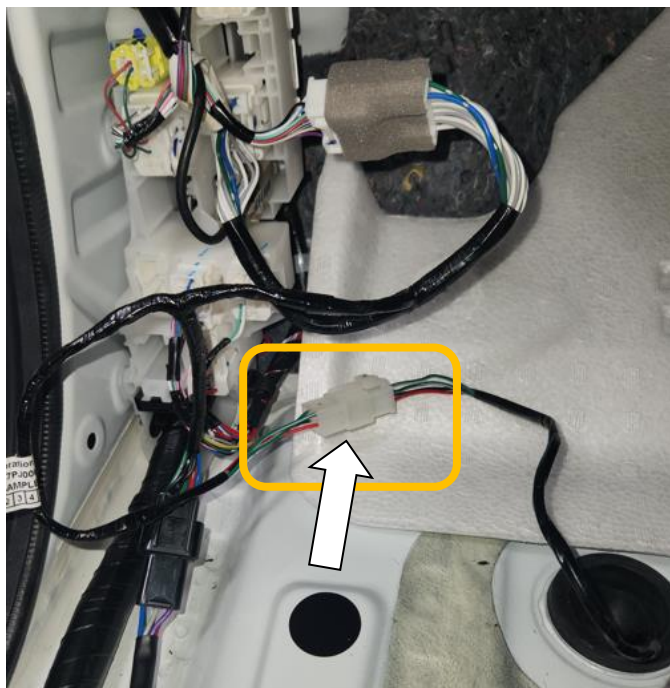
4.11) Connect the white connectors between the two parts of the canopy patch loom (667PJ006) at the foot well kick panel area.

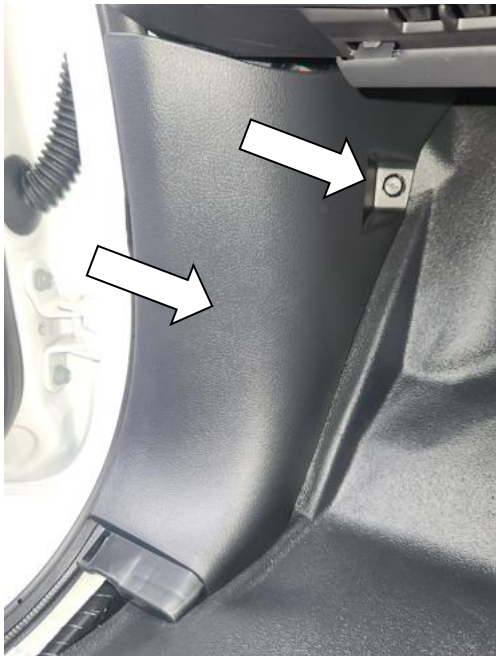
- 4.13) Reseat the floor carpet. Fit the kick panel cover and the retaining nut. Refit the door sill scuff plate.

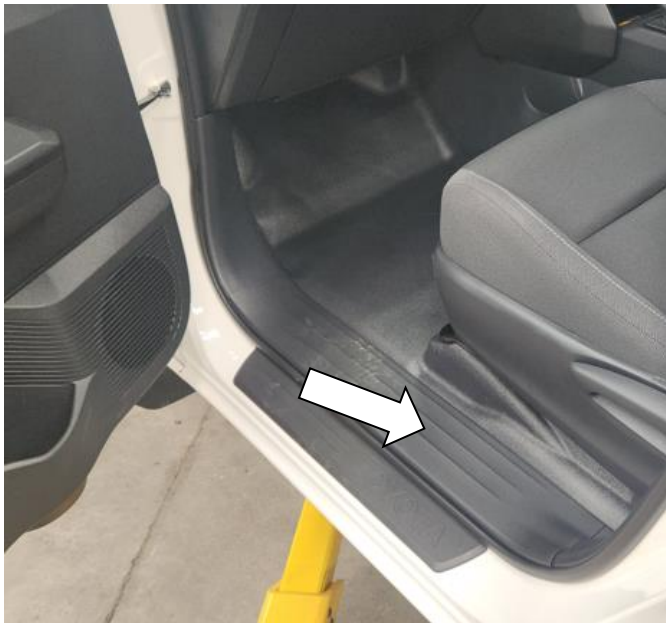
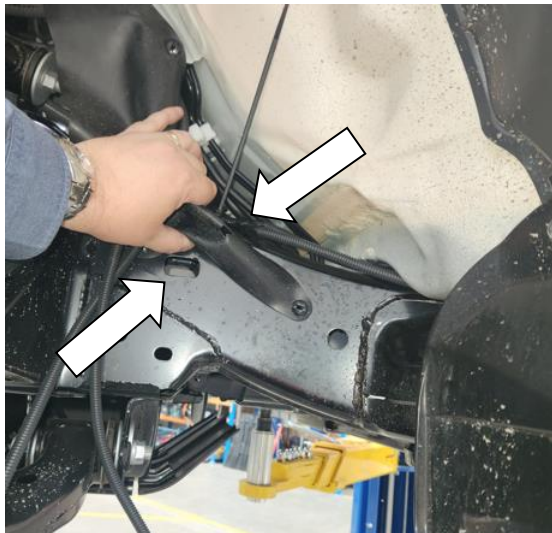
- 4.14) Under the vehicle, run the wiring with the two eye terminals forward along the top of left-hand chassis rail. Locate the large hole square hole through the chassis rail in the front wheel well area. After pulling all the loom to remove slack from the floor grommet position towards the front, cable tie the loom to the top of the chassis rail. **Ensure the loom is NOT tied to brake or fuel lines.**

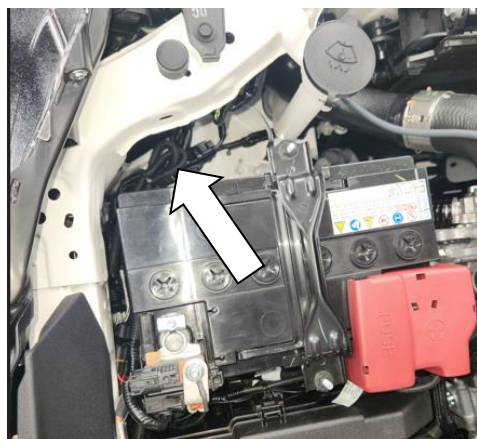
4.18) Cable tie the loom in place to the OEM battery cables in two places and refit the red positive battery terminal cover.

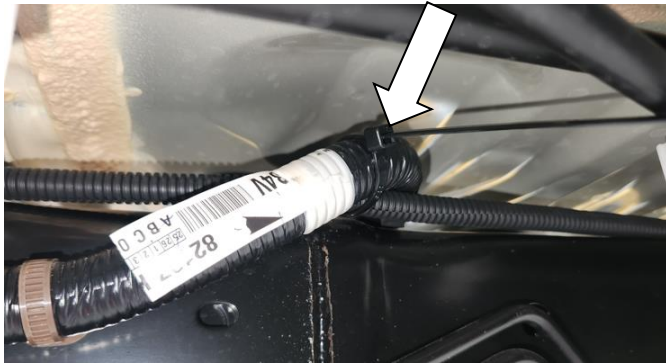
4.21) Running further reward, cable tie the canopy loom to the vehicle's OEM wiring harness where it goes over the top of the chassis rail.

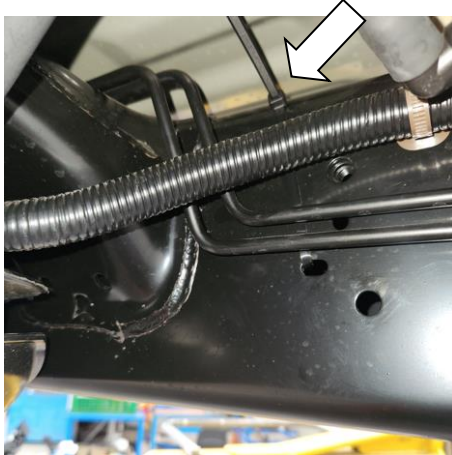
4.22) On the left-hand chassis rail, near the rear chassis crossmember. Cable tie the loom through the holes in the chassis rail so the loom sits on top of the chassis rail.

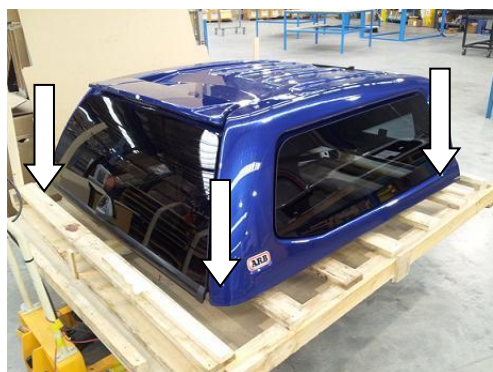
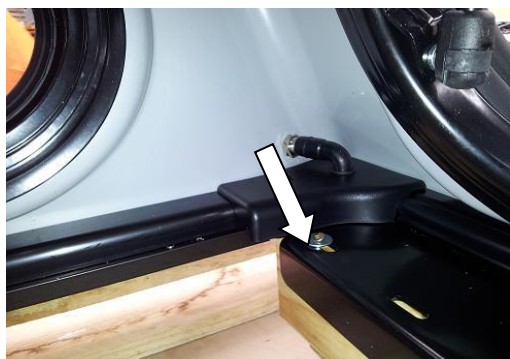
5.0) Unscrew the canopy on the pallet by removing the four wood screws in each corner. Gain access to screws via opening the rear door and front lift up window.

5.1) The front lift up window can be unlatched by reaching in underneath the canopy on the pallet and pushing forward on the glass in car position, to push the latch button upwards on both latches to unlock the window.

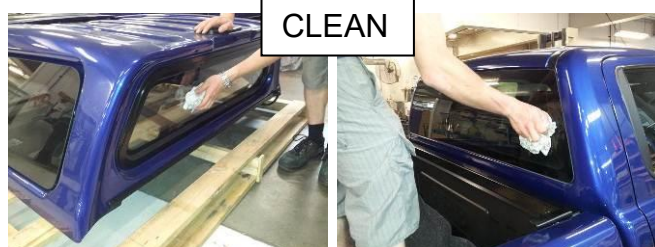
5.2) Clean the front window of the canopy on the outside.

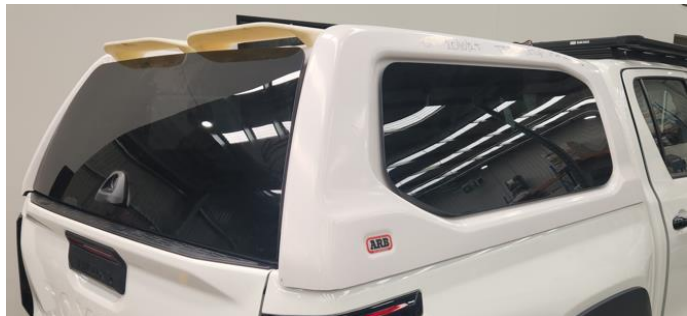
TOP VIEW OF FRONT CORNER OF CANOPY ON VEHICLE

FRONT LOWER TRIM EDGE OF SHELL TO ALIGN TO FRONT OF TUB

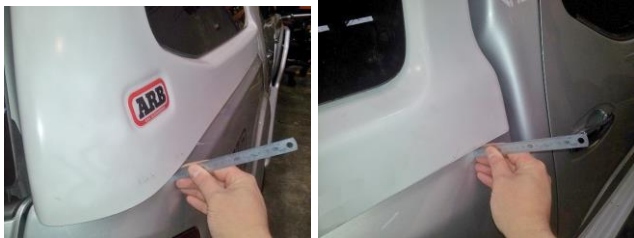
5.7) Measure the trim edges of the canopy at the rear sides and at the front both sides, to the vehicle's tub. **This measurement should be even on both sides of the canopy.**

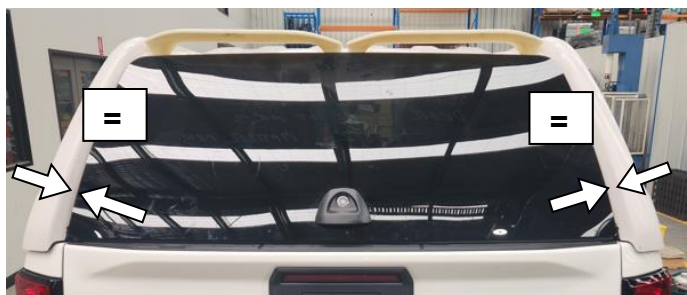
5.8) Stand back and walk around the canopy and check uniform balanced fit to the tub and cabin.

- The canopy is central on the Ute body.
- Alignment between cab and canopy is even both sides.
- The rear door seals against the tailgate cap evenly both sides without excessive force on glass to close.
- The gap is even between the door and shell on both sides.
- The gap of the door glass lower edge has gap to the tailgate cap to open.

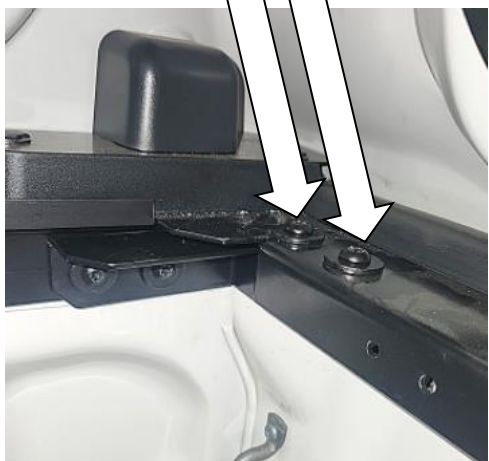
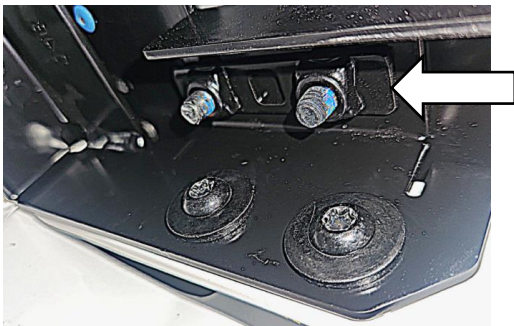
M8X25 TORX SCREWS (6151625) WITH M8x25.4x3 28 WASHER (4581303) ABOVE AND (667AQ024) 40MM PITCH NUT PLATE ON THE UNDERSIDE

5.9) On the inner edge of the front corner of the base rail inside the canopy, assemble two M8x25mm Torx head screws (6151625) with two M8x25.4x3mm washers (4581303) down in through the top of the base rail and through the two holes in the front corner mount bracket (667PD046R). On the underside use **the 40mm pitch nut plate (667AQ024)**. **Tighten the M8 Torx screws to 20Nm.**

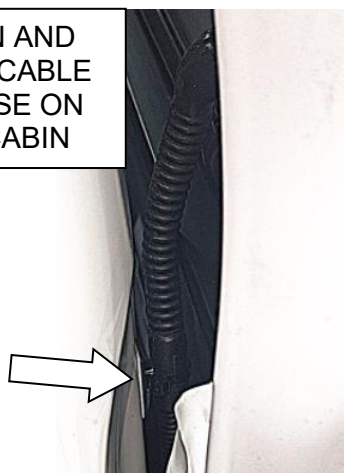
CLEAN AND PLACE CABLE TIE BASE ON THE CABIN

5.11) Cable tie the (6821293) cable tie base to the canopy loom at the front left-hand outer corner of the canopy, in the location shown (on the middle of the tube of the rubber grommet). Orientate the cable tie base so the adhesive side is towards the cabin.

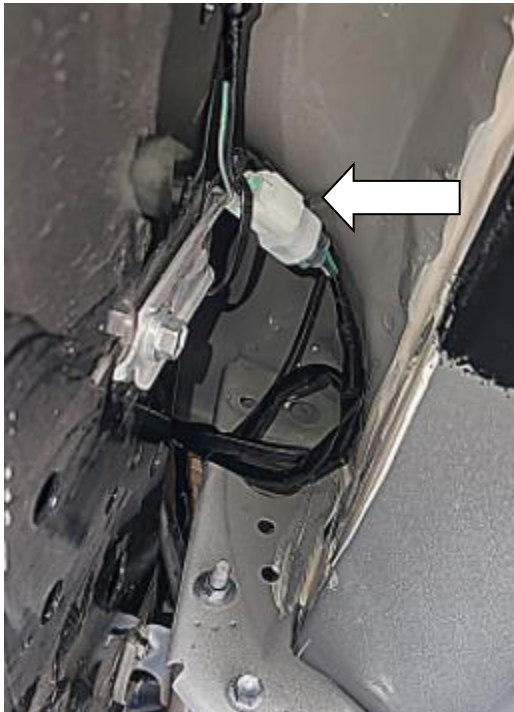
5.15) Connect the canopy wiring connector to the end connector of the canopy wiring harness (667PJ006) fitted to the vehicle, in the area above the left-hand chassis under the rear of the vehicle's cabin.

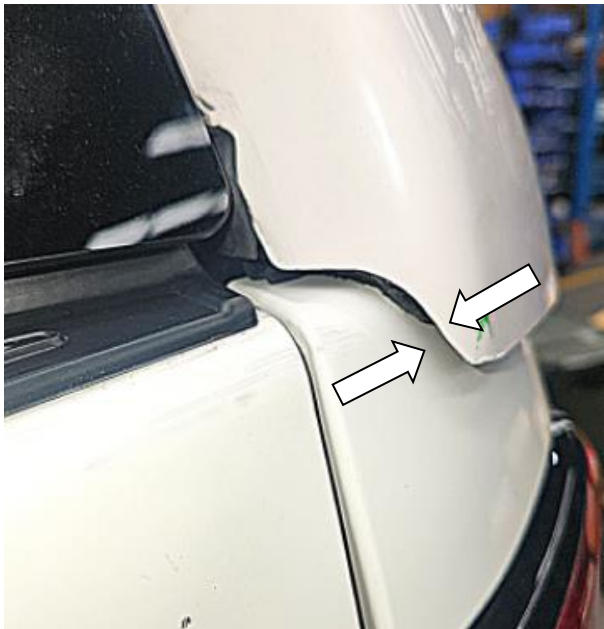
5.22) Check the gap of the canopy shell's trim edge corners to the tub. It should be even on both sides of the canopy.

**!! IMPORTANT !! The gap must not be below 9mm. Move the canopy rearward if required.**

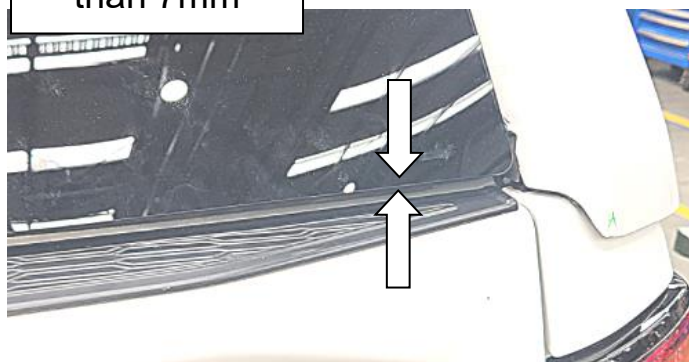
5.23) Position the canopy so the lower rear door glass edge's sash seal is sealing well and evenly along it's length to the tailgate cap. **Measure with a ruler vertically between the door glass lower edge to the top of the tailgate cap. (This distance must not be less than 7mm and should be even). 9-10mm is nominal condition.**

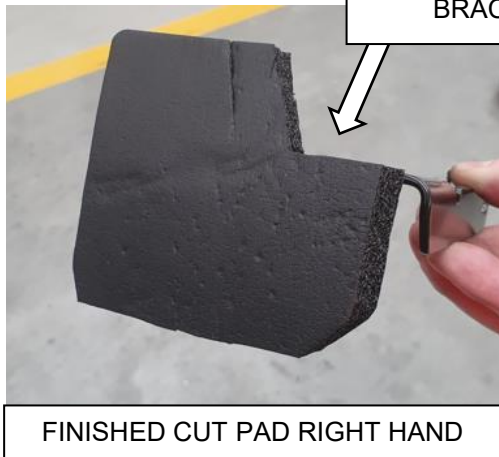
5.26) With sharp scissors cut two slits in the pad to the top edge of the bracket edge. Align the slits to be cut with slits visible on the face of the bracket.

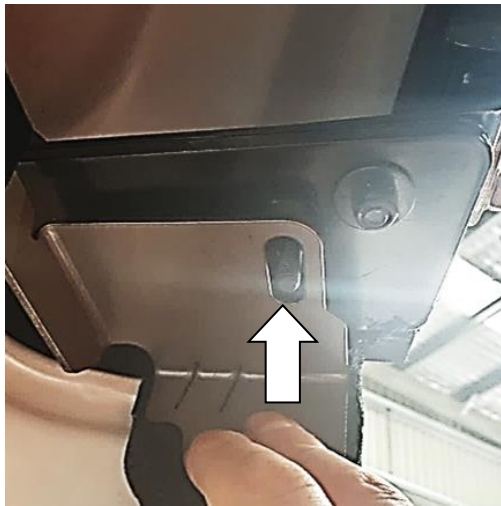
5.29) Locate and loosely assemble, the right-hand rear tub corner sealing bracket (667PD065R) with the rear leg inside the base rail return flange and the bracket upper face up to the underside of the base rail beneath the door frame with it's slot over the new M6 x 30 bolt.

5.30) Loosely assemble, new M6 nyloc nut (6151223) and M6 x 20mm x 1.2mm thick washer (4581082) to underside of door frame bracket to the new M6 x 30 bolt.

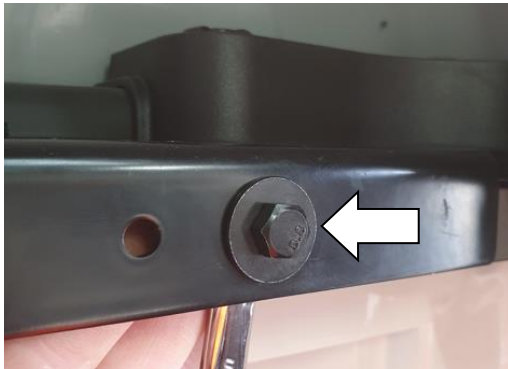
5.31) Through the base rail return flange to the rear tub corner sealing bracket, loosely assemble M6 x 20 bolt (6151213) with M6 x 20 x 1.2 washer (4581082) through it and on the inside assemble M6 x 20mm x 1.2mm thick washer (4581082) and M6 nyloc nut (6151223).

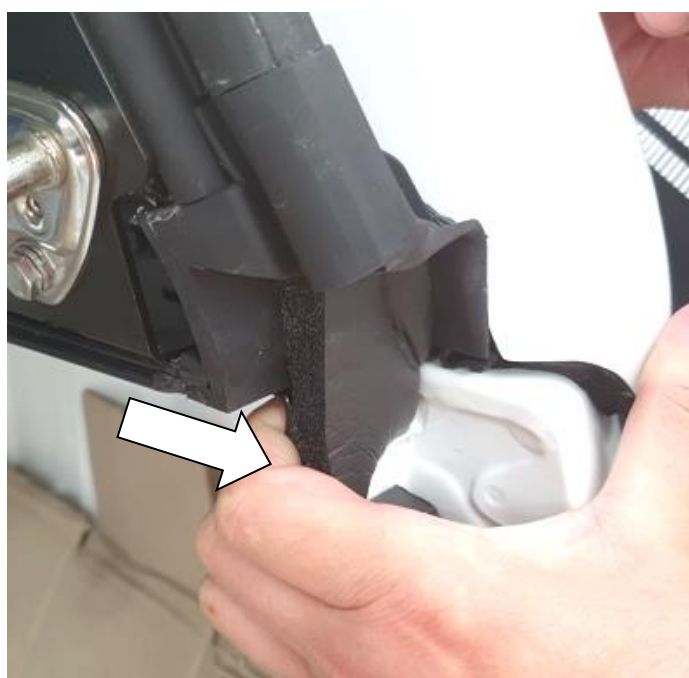
5.33) Pull the bracket rearwards to press up firmly against the inside surface of the tub corner pillar to compress the foam pad to at least half it's thickness.

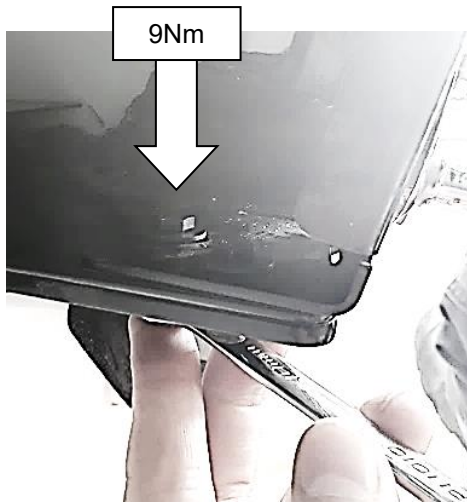
- 5.34) With the bracket pushed rearwards, tighten the M6 bolts to **9Nm** to set the bracket in place.

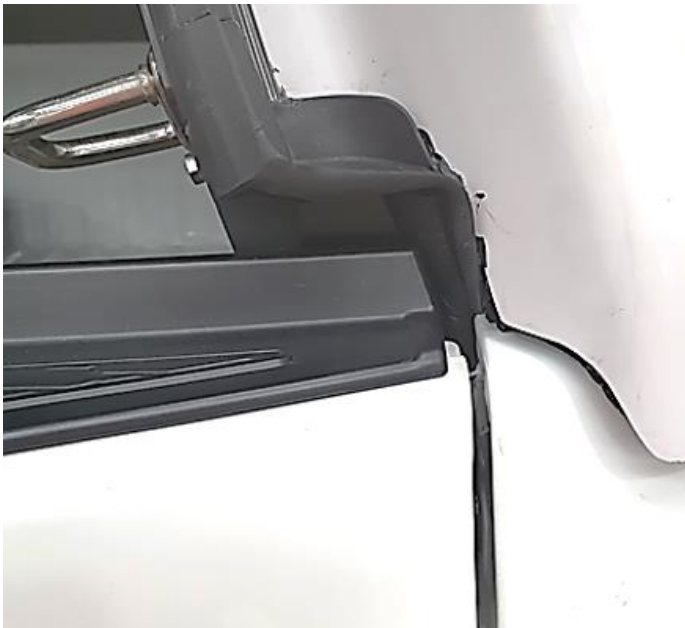
- 5.35) Close the tailgate to check the foam compression to the tailgate. Check the tailgate can be closed without excessive force to close it against the seal compression. Check also the foam pad seals up to the back of the plastic tailgate cap.

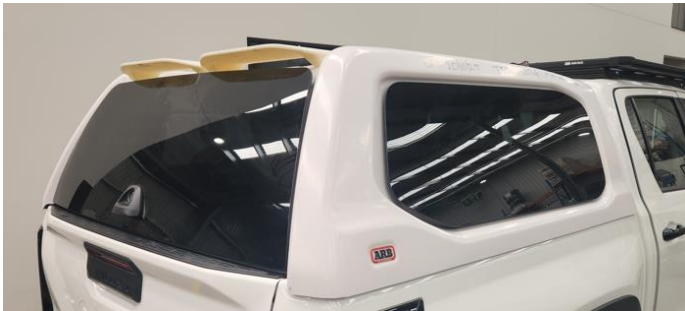
- 5.38) Water test the canopy around all windows and joins to the tub with high pressure hose and seal or report any leaks found.

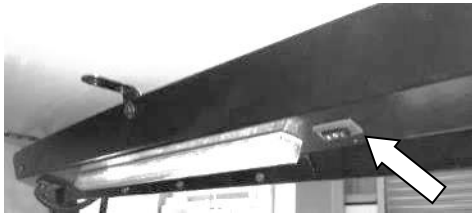
6.0) Move the interior light switch to the position II where it will turn off when the door is closed and turn on when the door is opened.

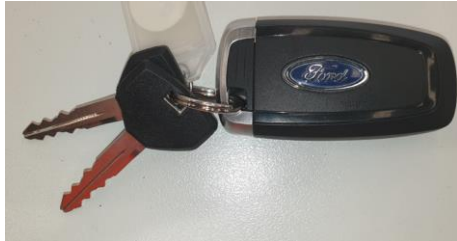
6.2) Remove the key from the rear door handle and combine this with the key taped inside the canopy. The two keys should then be added to the customer's key ring.

**!! IMPORTANT !! Check BOTH keys work manually in the rear door lock.**

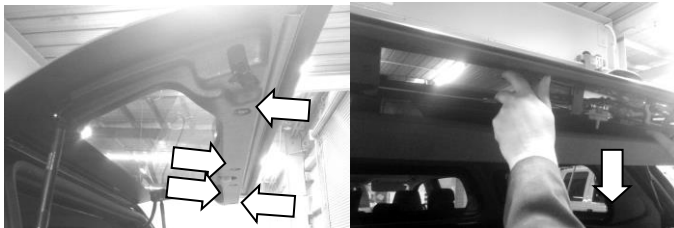
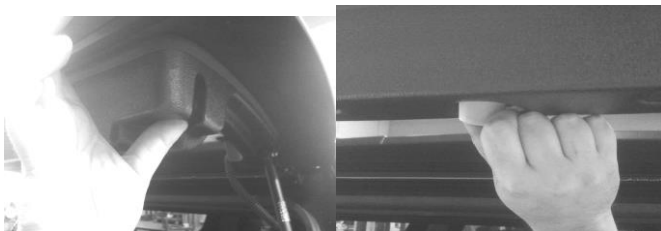
Press the button underneath to operate electric door actuator mechanism.

6.3) Operate the door push button switch to open and close the door. **If one side opens before the other, the lock mechanism can be adjusted so that both sides of the door open simultaneously if the following is done:**

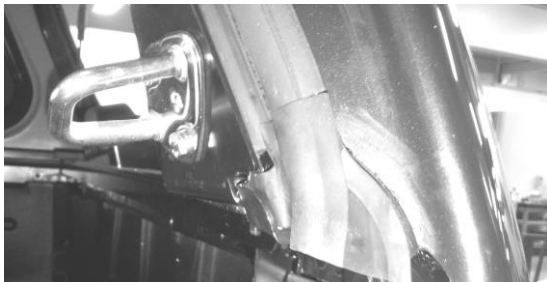
- If the latches do not operate simultaneously, locate the black plastic clips on each end of the pull rods to the latches, unclip a pull rod, lengthen or shorten it by winding it in/out and re-clip in. Close the latches with your fingers again and test operation via the interior rear door handle to operate simultaneously.
- Once satisfied, refit the door cover lower portion with the scriveners, but ensure to guide the pull rods into slits in the foam blocks on the door cover at both ends.

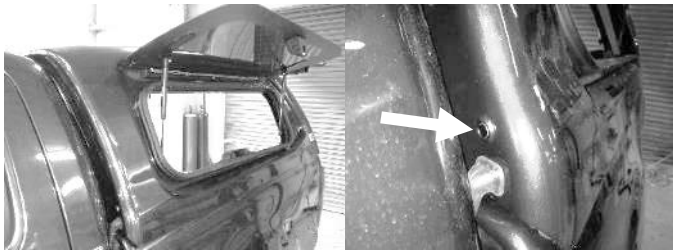
**If the latches can be seen to bind on the door frame strikers, it may be necessary to adjust the door frame strikers.**

**Do this by the following:**

- Place one thickness of masking tape around the striker bar where the latches contact. Open and close the door. If the tape shown signs of wear through on the top side or underneath of the striker bar, it is necessary to adjust the striker away from the side on which the wear is shown. **The aim is only to have wear on the outward face of the striker bar.**
- Undo the M6 screws slightly on the strikers and adjust their position slightly. **Re-torque screws to 9Nm.**
- Test the door again and adjust via the above methods until satisfied.

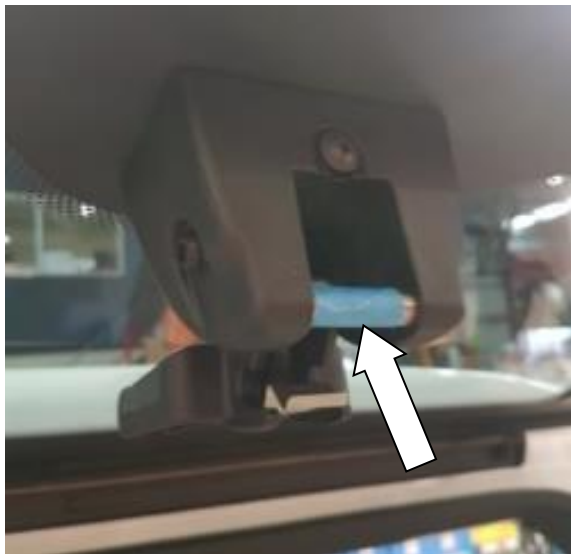
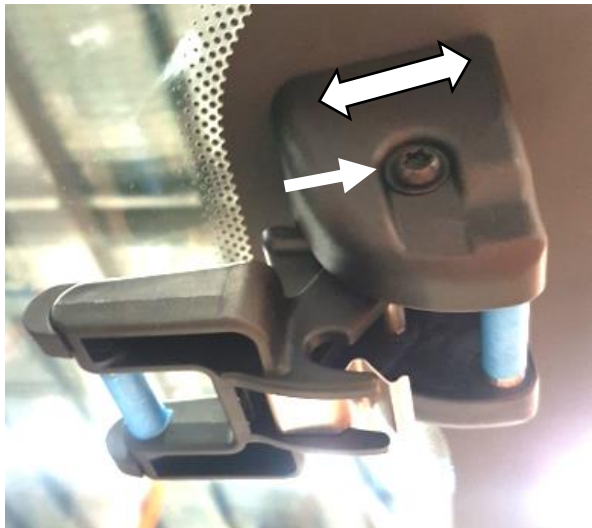
6.4) Operate the push button switch on side lift up windows. If the windows will not latch properly, and the solenoid can be heard working, the latch can be adjusted in the following steps.

- Remove the rotary latch plastic cover on the window frame.
- Operate the window with a person outside pushing the button and closing the window slowly. Look to see the striker bar on the glass does not scuff the leg on the rotary latch pawl as the window closes. The striker bar should close into the middle of pawl slot on the rotary latch on the frame. Place one thickness of masking tape around the striker bar where the latch contacts. Open and close the window. If the tape shows signs of wear through on the top or underside of the striker bar, it is necessary to adjust the striker away from the side on which the wear is shown. **The aim is only to have wear on the outward side of the striker bar not above or below in closed position.**

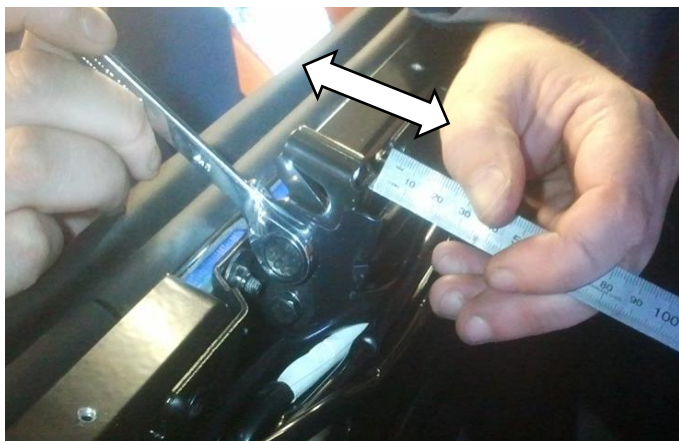
- The rotary latch on the window frame provides window in/out adjustment. Measure the distance between the back of the rotary latch and its mounting bracket and take note of it (9mm). Loosen the bolts through the latch and move the latch out 1mm at a time and **re-tighten to 9Nm** and test the window until it opens and closes and seals satisfactorily.
- Refit the cover over the latch mechanism and ensure wiring inside is coiled up neatly and cannot interfere with the latch mechanism.
