# FITTING INSTRUCTIONS

## DUAL CAB CANOPY- CENTRE HANDLE REAR DOOR

### Classic Canopy CLS81 – Toyota Hilux

(2026+ Vehicle Production Onwards)

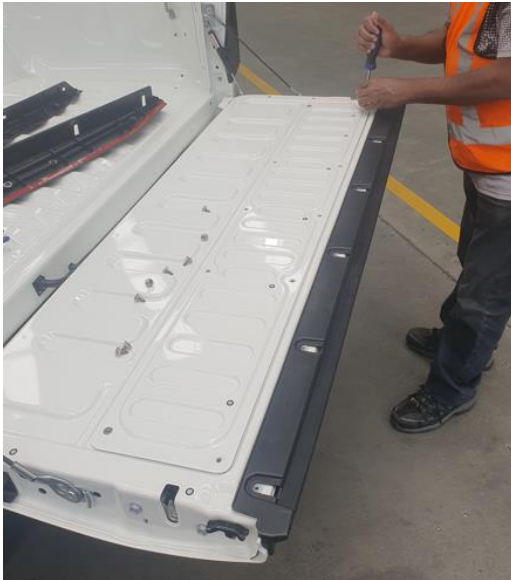
2.0) Place tailgate in down position.

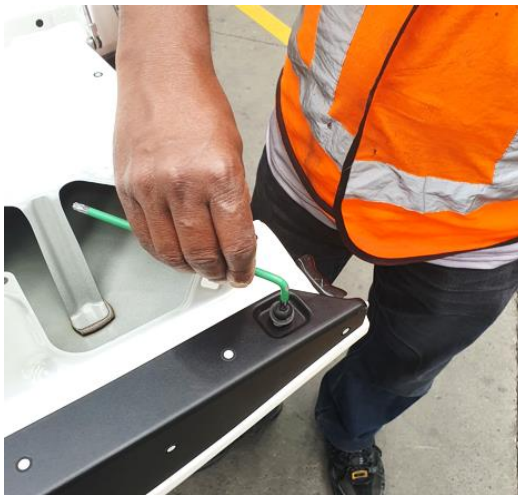
2.1) Remove all the Torx T30 screws holding the OE plastic tailgate cap in place on the back side of the tailgate. Retain the screws to re-use.

2.2) Use Phillips head screwdriver driver to remove tailgate metal access cover. Retain all parts to reuse.

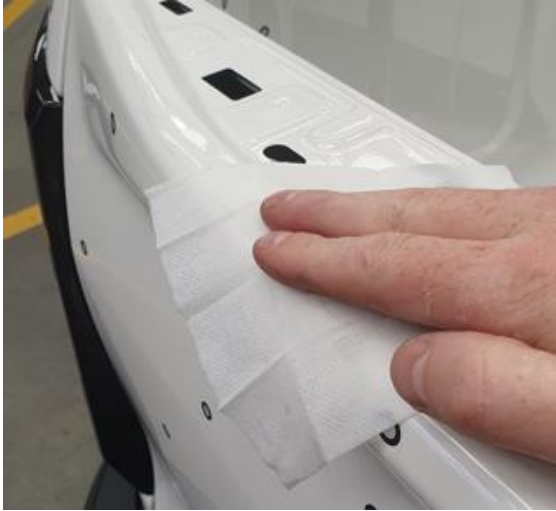
2.5) Clean the top leading edge of the tailgate with an alcohol wipe (602018) and allow it to dry. Use a primer stick (665044) along the top flat face **ONLY**, sparingly, without spillage and allow to dry.

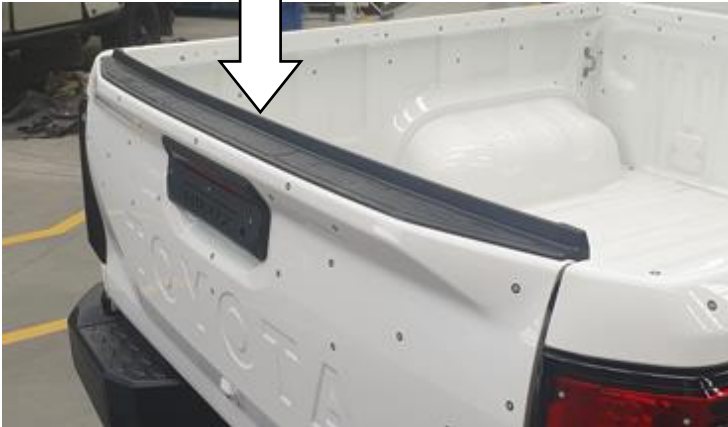
LOCATE NEW CAP IN  
POSITION

2.7) Close the tailgate. Position the assembly to align it to the top of the tailgate. The locator spigots on the new tailgate cap moulding will provide accurate positioning into the tailgate sheet metal.

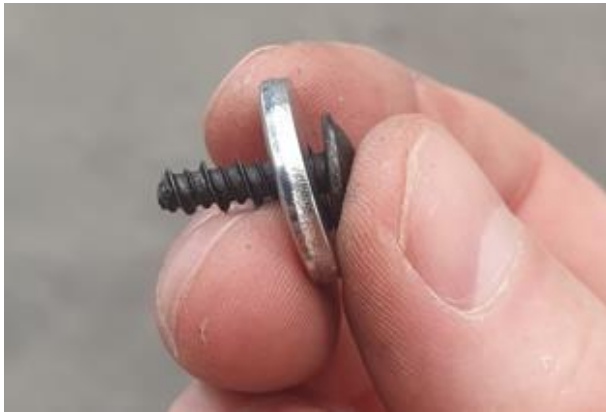
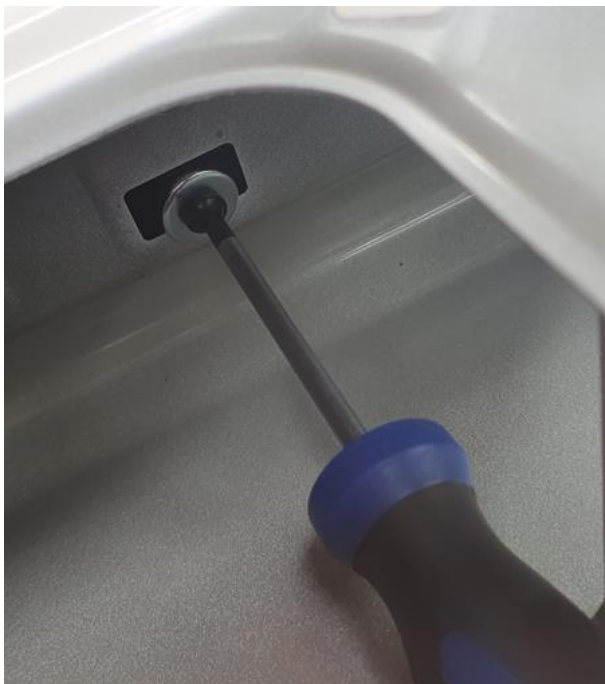
2.9) From inside the tailgate cavity, beginning at the ends, progressively screw down the new tailgate cap firmly in six places using the Hi-Lo screws (6151626) and M5x19 x3mm thick washers (4584463) on the inside. Do this by hand using a Phillips head screwdriver to avoid stripping the screws.

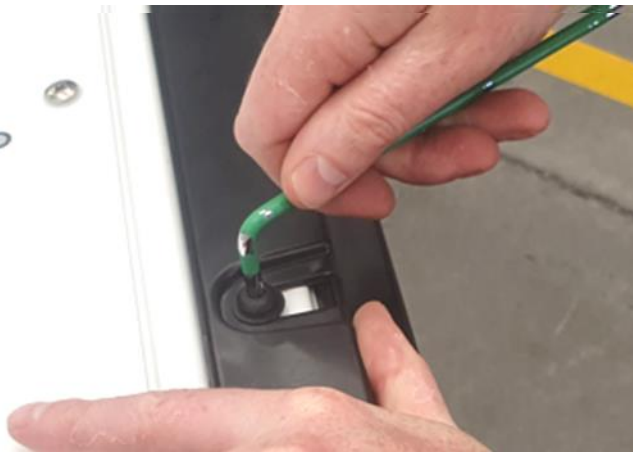
2.10) While pushing down on the new tailgate cap, with a T30 Trox drive, screw down tailgate stop using the original retained OE screws in six places. Hand-tighten, do not use an electric drill and do not overtighten to avoid stripping.

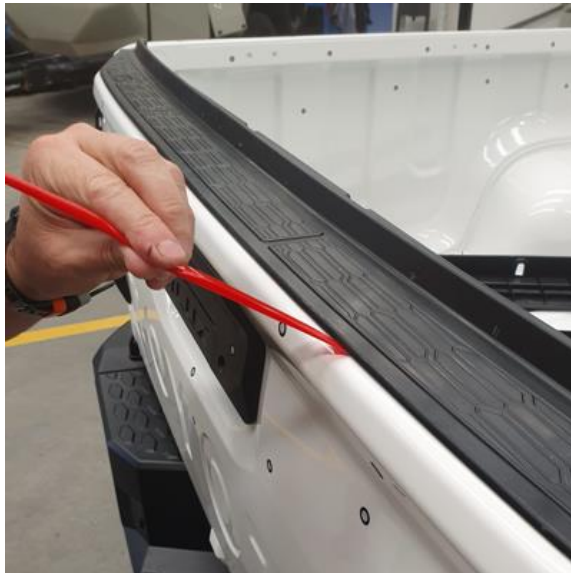
2.11) Close the tailgate and slowly pull out the remaining tape liner. Then push down all along taped edge to wet out tape to sheet metal.

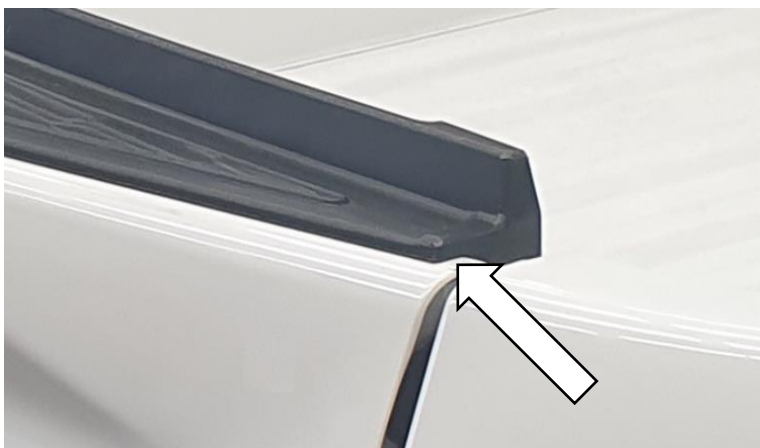
2.12) At each end of the tailgate cap and on the ends only, apply a small amount of (neutral cure non-acetic) silicon to the join between the cap and the tailgate. Carefully, clean off excess with a rag applied sparingly with silicon remover, or wax and grease remover and make the joins neat.

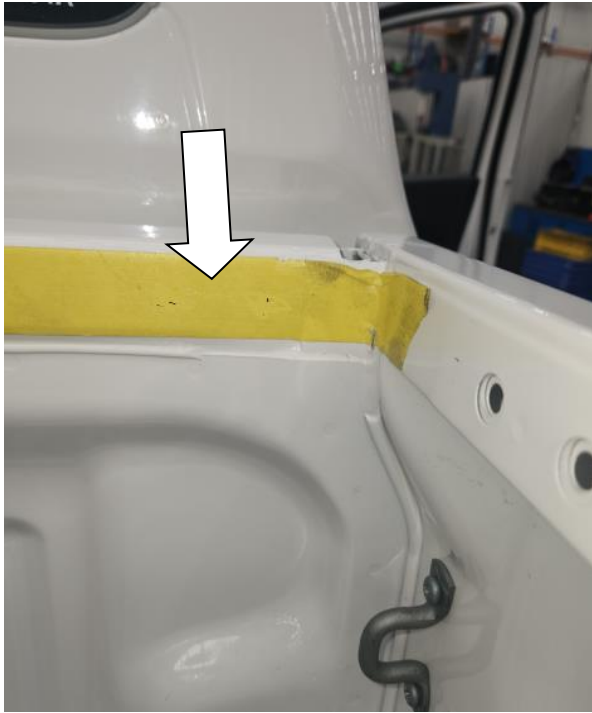
- 3.0) **For vehicles fitted with cabin guards ONLY that were removed in Section 1:**  
Apply masking tape across the front inner corners of the vehicle's tub to approximately 200mm inboard.

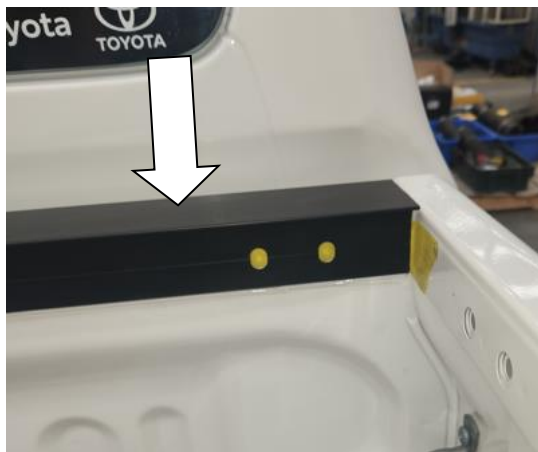
- 3.1) **For vehicles fitted with cabin guards ONLY that were removed in Section 1:**  
Place the front header rail bracket assembly (667AQ018) down on the front wall of the tub with the foam tape underneath the header rail pressed against the top of the front upper surface of the tub. Locate each end of the assembly **with even gaps to both sides of the tub.**

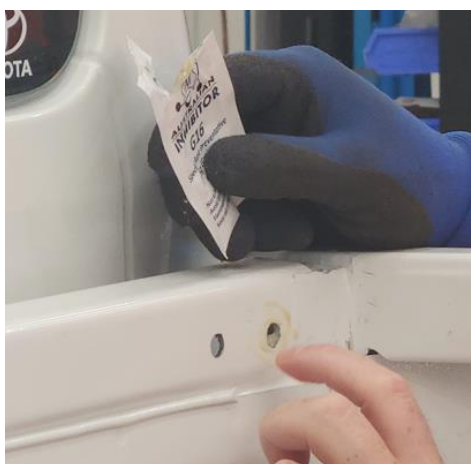
- 3.3) **For vehicles fitted with cabin guards ONLY that were removed in Section 1:** Centre punch the centres of the holes and drill them out to 10mm. Deburr the holes. Remove the masking tape and apply rust inhibitor (665505) to the edges of the drilled holes.

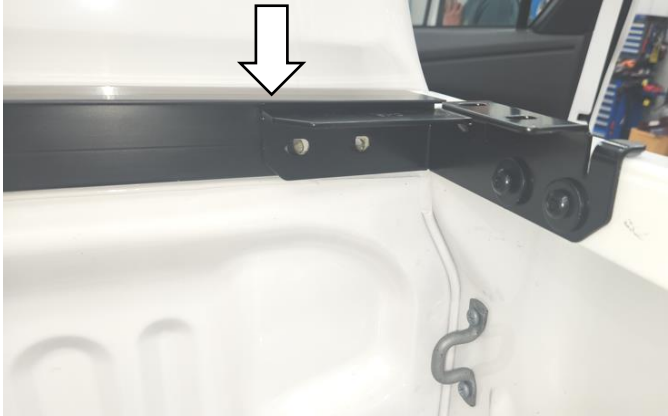
3.7) Place in the front header rail bracket assembly (667AQ018) down between the front corner mount brackets and the front wall of the tub with the foam tape underneath the header rail pressed against the top of the front upper surface of the tub. Locate each end of the assembly with even gaps to both sides of the tub.

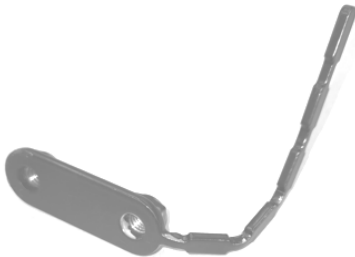
3.8) Fit between the cabin and the tub the nut plate (4655378) to align to the two holes in the corners of the tub. The end of the nut plate may be bent to a shape to provide access for fitment. Place masking tape on the back of the cabin before it is inserted to prevent scratching the cabin's paint work.

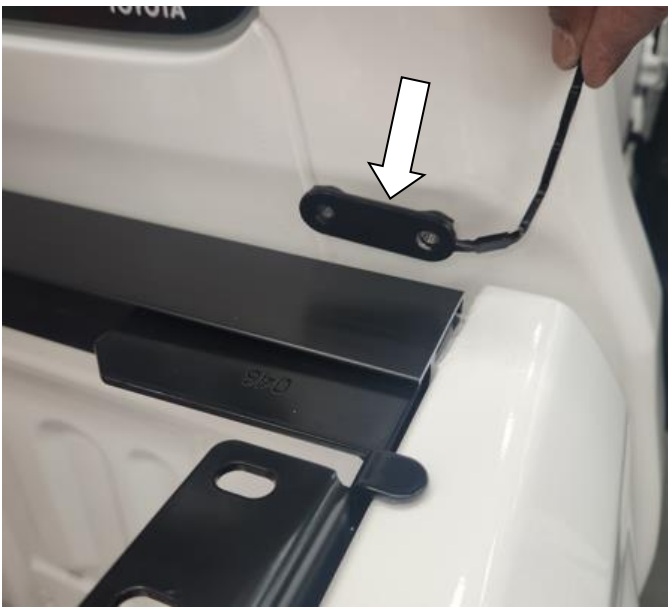
Bend down in  
behind vehicle tub  
("A")

3.9) Loosely bolt up the header rail through the front corner mount brackets (667PD046R/L) using two M8 x 25 OD x 3mm thick flat washers (4581303) and two M8 x 35 Torx button head screws (6151881) per side, through the header rail assembly and through the tub into the nut plate (4655378) on the other side of the tub between the cabin. Tighten, but allow brackets to still be slightly loose.

3.10) Once assembled, bend the tag from the nut plate down in behind the vehicle's tub and ensure it cannot make contact with the cabin. (Location "A")

3.12) Do up the front M8 Torx screws through the corner brackets and front header rail first, to **20Nm Torque whilst ensuring the tub mount bracket top face tags are engaged against the top face of the sides of the tub. (Location "B").**

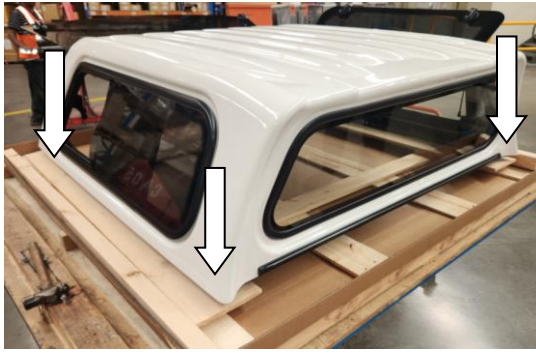
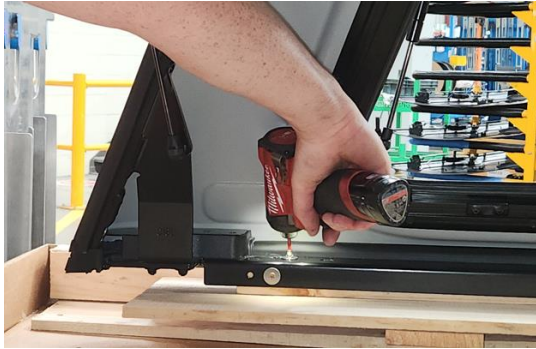
4.0) Unscrew the canopy on the pallet by removing the four wood screws in each corner holding the canopy down through the top of the base rails to the pallet. Gain access to screws via opening the rear door and via side lift up windows.

4.1) Also remove the four screws holding the four timber bearers on the inner flange of the base rails.

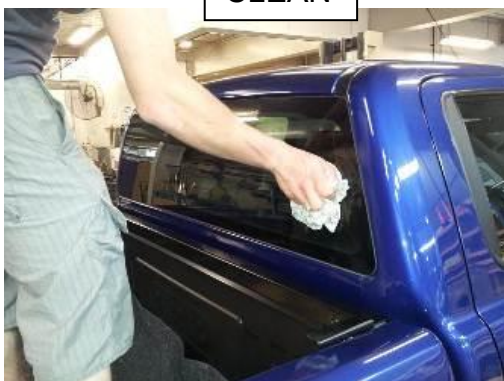
4.2) Clean the front window of the canopy on the outside.

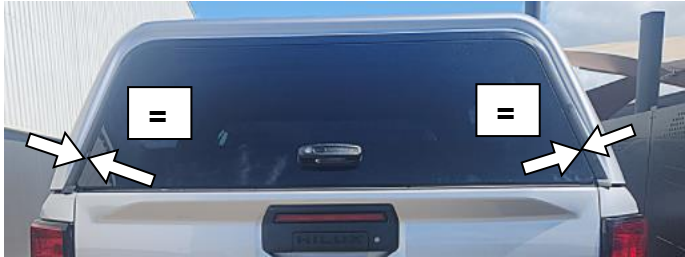
- 4.7) Stand back and walk around the canopy and check uniform balanced fit to the tub and cabin.
- The canopy is central on the Ute body.
  - Alignment between cab and canopy is even both sides.
  - The rear door seals against the tailgate cap evenly both sides without excessive force on glass to close.
  - **The gap is even between the door glass to the frame on both sides at more than 3.5mm each side.**
  - The gap of the door glass lower edge has gap to the tailgate cap to open.

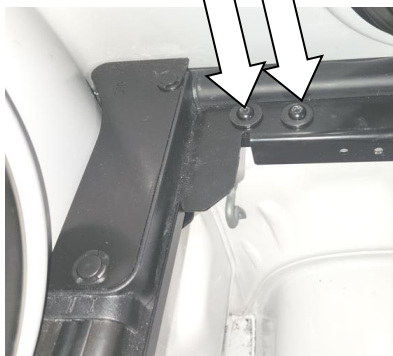
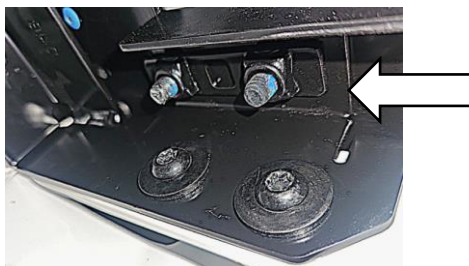
M8X25 TORX SCREWS (6151625) WITH M8x25.4x3 28 WASHER (4581303) ABOVE AND (667AQ024) 40MM PITCH NUT PLATE ON THE UNDERSIDE

- 4.8) On the inner edge of the front corner of the base rail inside the canopy, assemble two M8x25mm Torx head screws (6151625) with two M8x25.4x3mm washers (4581303) down in through the top of the base rail and through the two holes in the front corner mount bracket (667PD046R). On the underside use **the 40mm pitch nut plate** (667AQ024). **Tighten the M8 Torx screws to 20Nm.**

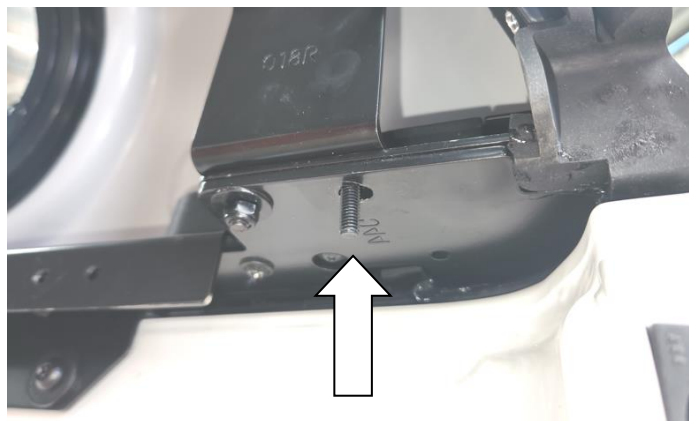
- 4.15) Open the tailgate. Inside the canopy's rear corner on the right-hand side, remove the bolt through the door frame support bracket and the canopy base rail in the rearmost location and replace it with M6 x 30mm long hex bolt (6151228) and retained washer. Retain the other washers and discard the M6 nyloc nuts. Both Sides.

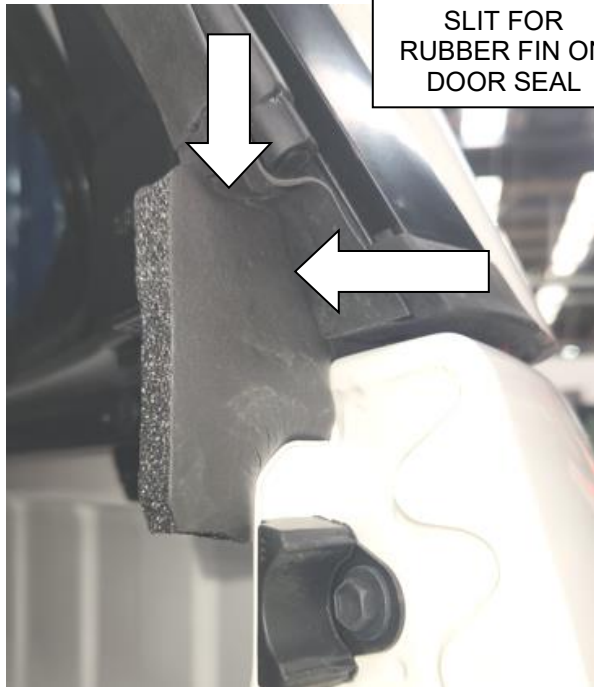
4.19) Adhere the rear face of the foam pad to the front face of the rubber door frame corner seal, ensuring the corners of the foam pad butt up to the corners of the door frame seal.

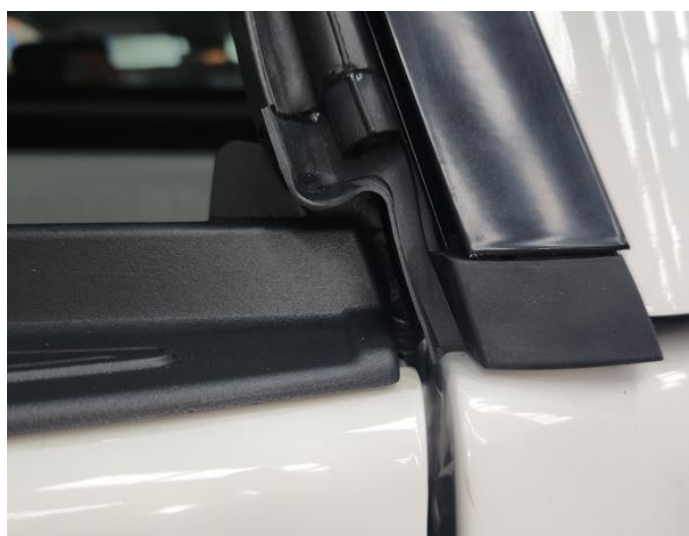
- 4.22) Close the tailgate to check the foam compression to the tailgate. Check the tailgate can be closed without excessive force to close it against the seal compression. Also check the foam pad seals up to the back of the plastic tailgate cap.

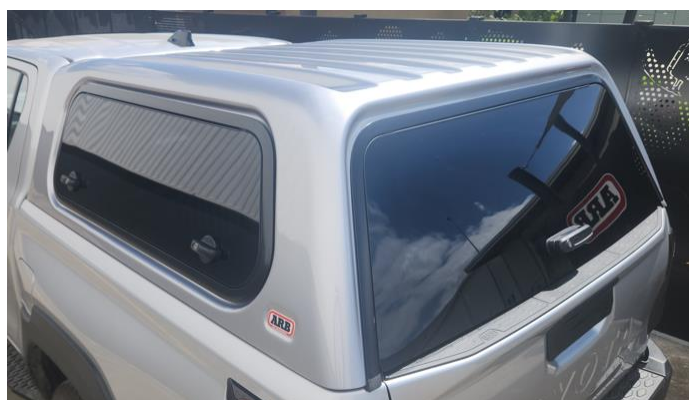
4.25) Water test the canopy around all windows and joins to the tub with high pressure hose and seal or report any leaks found.

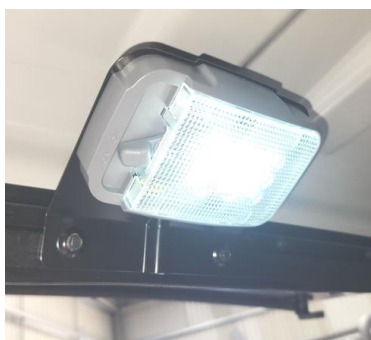
5.0) Check the interior light works when turned on via the switch. The light is battery operated with four AA batteries which can be accessed via removing the lens.

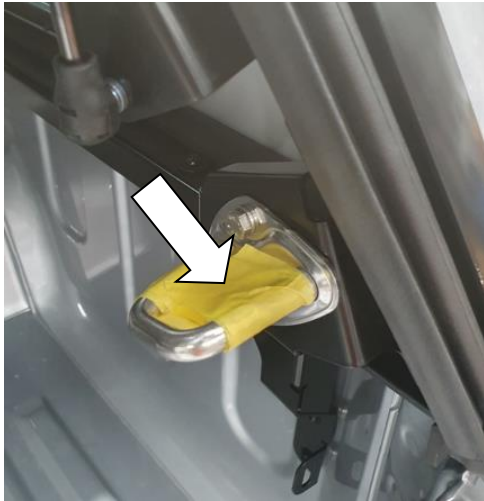
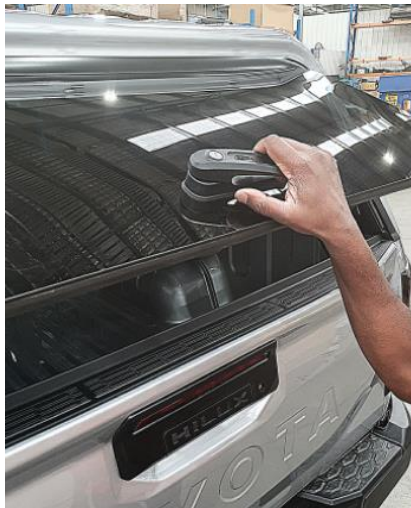
- 5.2) Place masking tape around the stainless-steel striker loops on both sides of the door and slam the door shut 3 times.

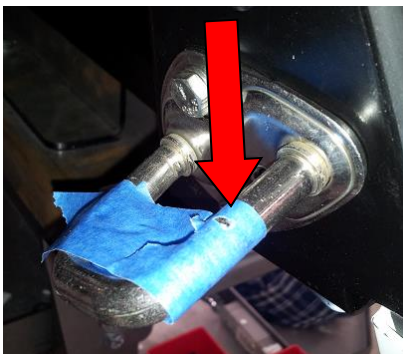
- 5.3) Check there is only wear on face of the tape that is rearwards from the vehicle on the striker loops.
- 5.4) If there is wear on top or underneath on the striker loop, loosen the bolts on the striker loops and adjust the position of the loop up or down to correct strike position into the rotary latches on the door glass so they do not bind when closing the door.
- 5.5) Tighten and retest with tape again until the desired latch wear point is obtained. Once satisfied, tighten the striker loop bolts to **9Nm**, using a torque wrench

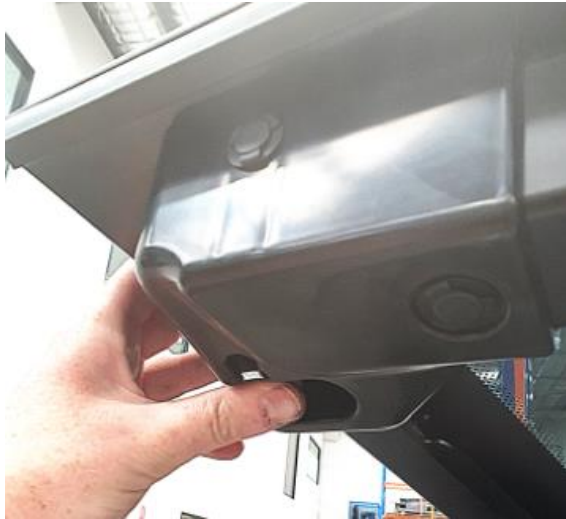
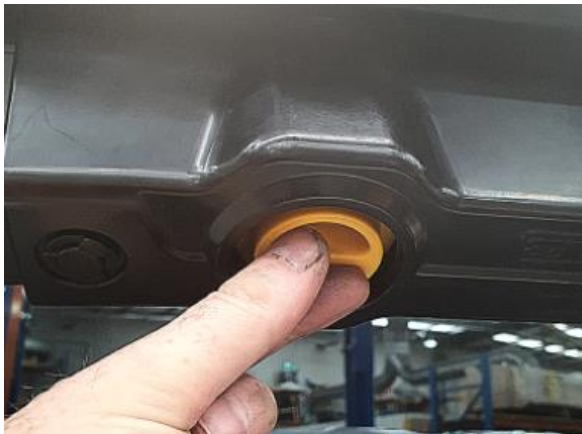
5.6) With the door open, engage both latches to close them by pushing in the rotary latch pawls on both sides of the door, then **SLOWLY** twist the yellow release handle at the centre of the door and listen to hear if both latches open at **EXACTLY** the same time.

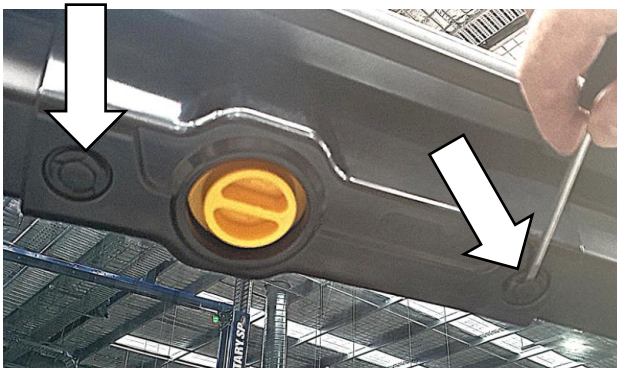
5.7) If the latches don't release at the same time, remove the 2 screws retaining the centre door cover, remove the cover to get access to the latch pull rods inside.

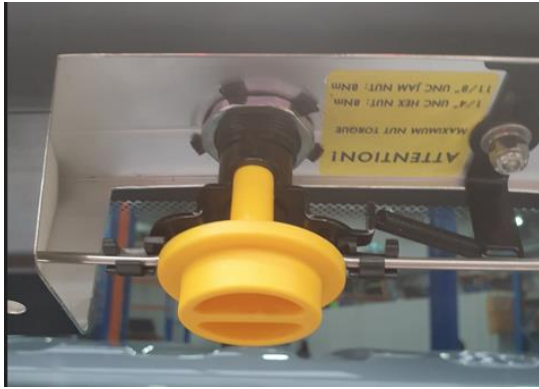
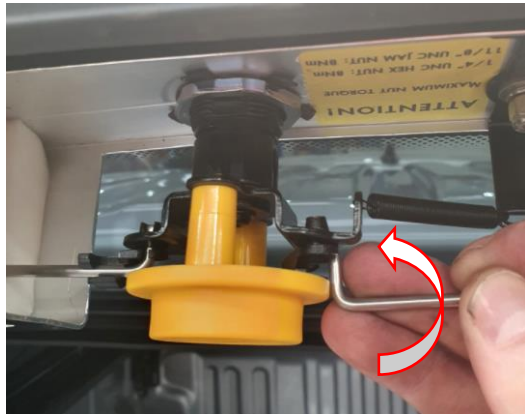
- 5.8) On the side which released last, undo the rod clip and pull the pull rod out. Rotate 1 turn to shorten it.
- 5.9) Reinstall the rods into the clips, **CLIP THE ROD END SHUT.**
- 5.10) Retest the latches by operating the interior handle to check they work simultaneously.

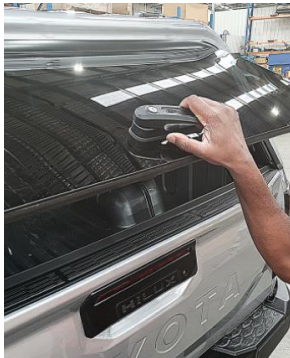
- 5.11) **Shut the door as gently as possible for a latch to engage.** Check that both latches engage at **EXACTLY** the same time.

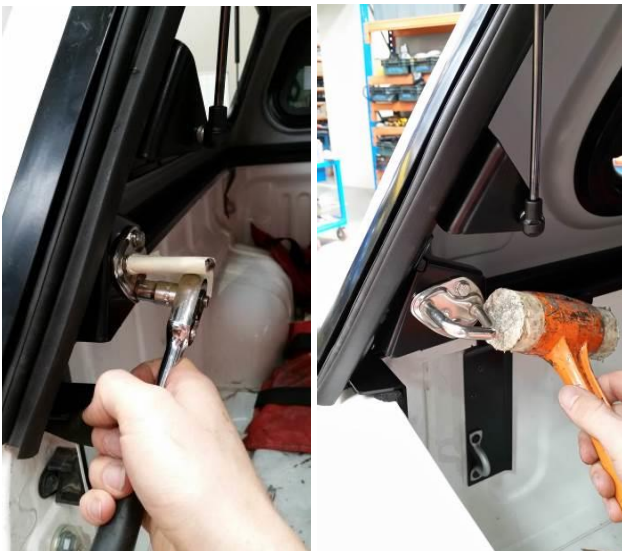
- 5.12) If the latches don't engage at exactly the same time, loosen the 2 stainless steel M6 bolts on the striker loops and tap the latch striker forward 1-2mm.
