## DUAL CAB CANOPY

### Classic Canopy CLS82 – Toyota Hilux

(2026+ Vehicle Production Onwards)

**FITTING KIT: TAILGATE AND HEADBOARD KIT 6178585. TUB MOUNT KIT 6178717**

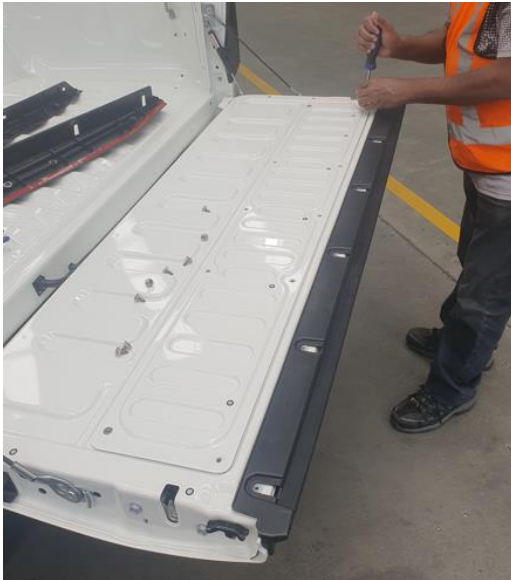
2.0) Place tailgate in down position.

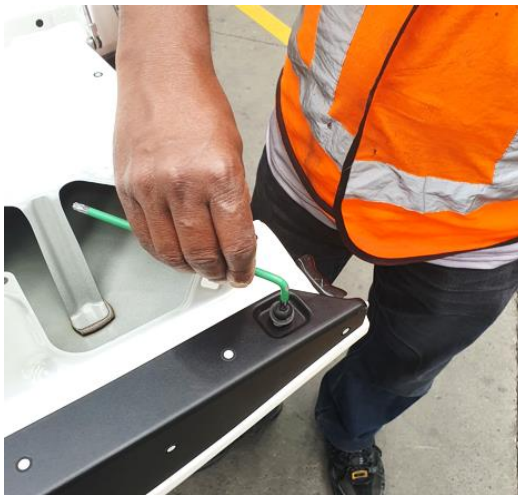
2.1) Remove all the Torx T30 screws holding the OE plastic tailgate cap in place on the back side of the tailgate. Retain the screws to re-use.

2.2) Use Phillips head screwdriver driver to remove tailgate metal access cover. Retain all parts to reuse.

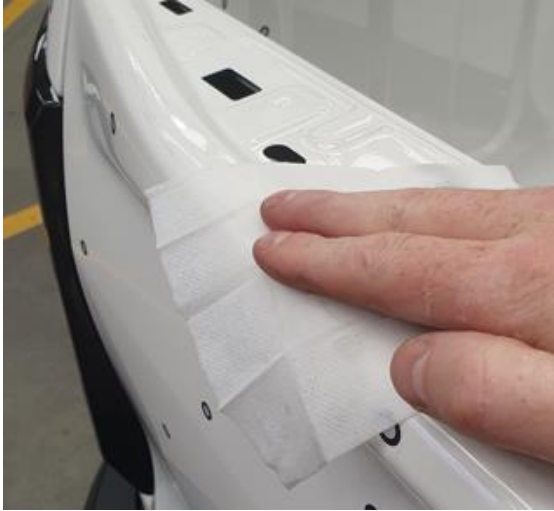
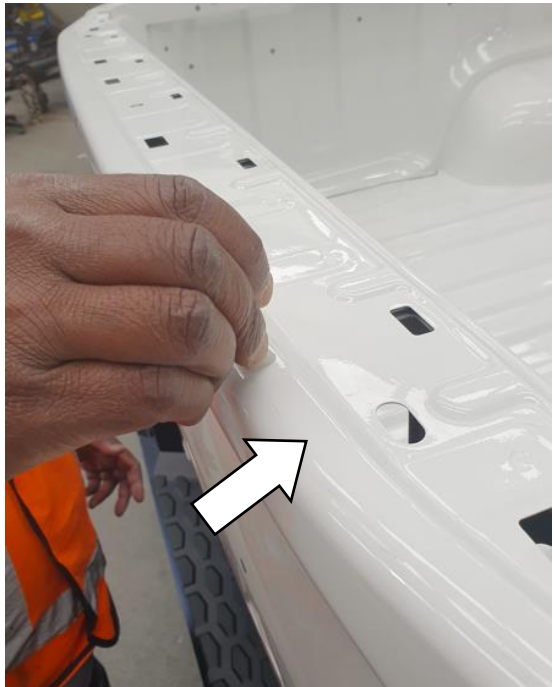
2.5) Clean the top leading edge of the tailgate with an alcohol wipe (602018) and allow it to dry. Use a primer stick (665044) along the top flat face **ONLY**, sparingly, without spillage and allow to dry.

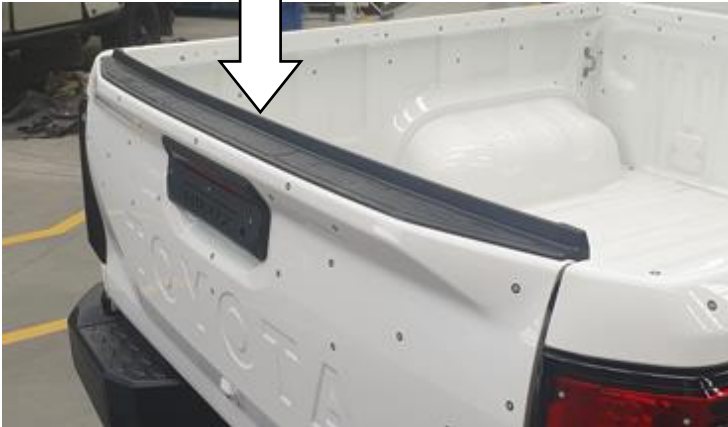
LOCATE NEW CAP IN  
POSITION

2.7) Close the tailgate. Position the assembly to align it to the top of the tailgate. The locator spigots on the new tailgate cap moulding will provide accurate positioning into the tailgate sheet metal.

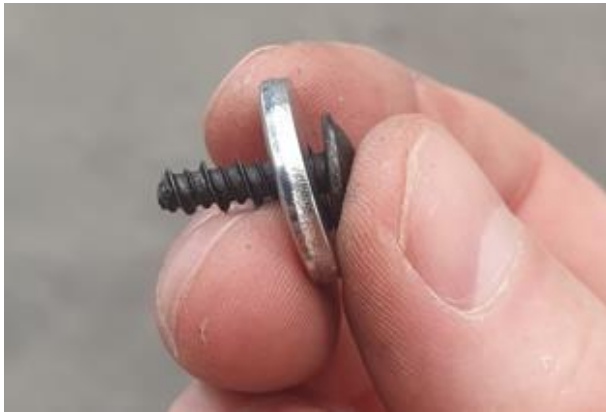
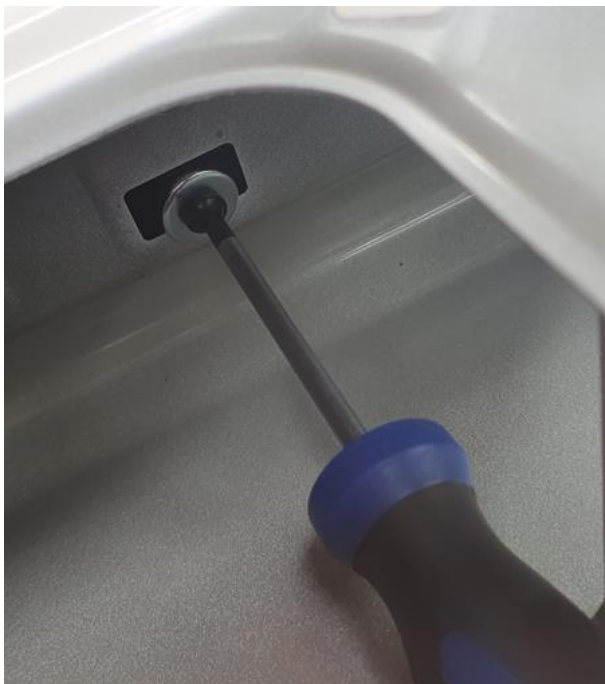
2.9) From inside the tailgate cavity, beginning at the ends, progressively screw down the new tailgate cap firmly in six places using the Hi-Lo screws (6151626) and M5x19 x3mm thick washers (4584463) on the inside. Do this by hand using a Phillips head screwdriver to avoid stripping the screws.

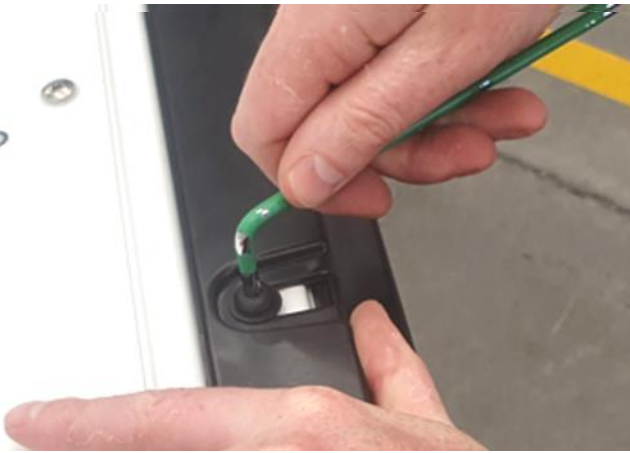
2.10) While pushing down on the new tailgate cap, with a T30 Trox drive, screw down tailgate stop using the original retained OE screws in six places. Hand-tighten, do not use an electric drill and do not overtighten to avoid stripping.

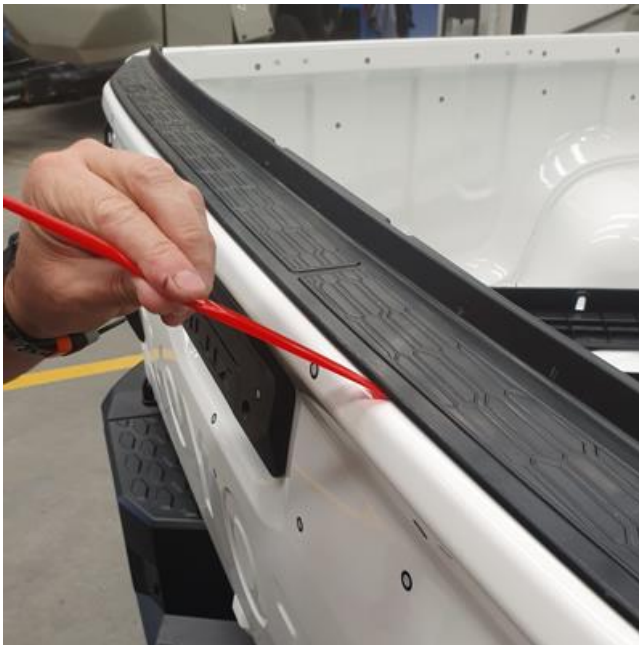
2.11) Close the tailgate and slowly pull out the remaining tape liner. Then push down all along taped edge to wet out tape to sheet metal.

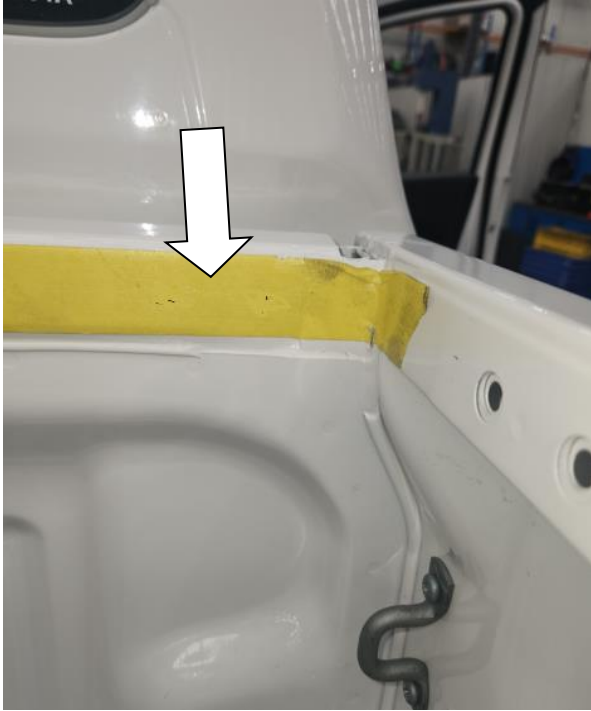
- 3.0) **For vehicles fitted with cabin guards ONLY that were removed in Section 1:**  
Apply masking tape across the front inner corners of the vehicle's tub to approximately 200mm inboard.

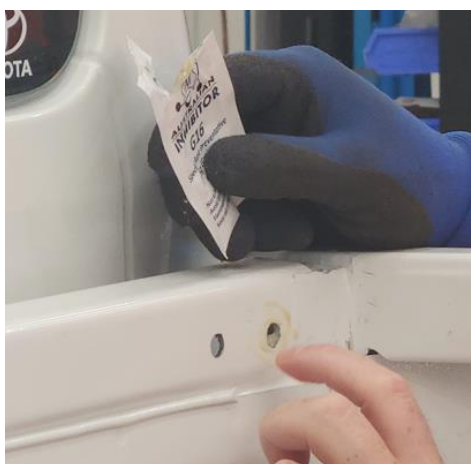
3.3) **For vehicles fitted with cabin guards ONLY that were removed in Section 1:** Centre punch the centres of the holes and drill them out to 10mm. Deburr the holes. Remove the masking tape and apply rust inhibitor (665505) to the edges of the drilled holes.

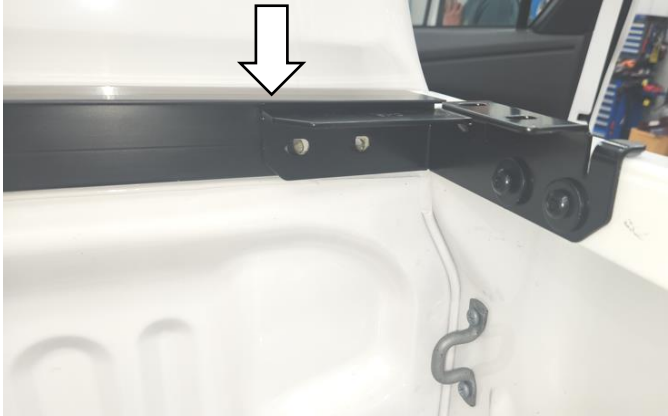
3.7) Place in the front header rail bracket assembly (667AQ018) down between the front corner mount brackets and the front wall of the tub with the foam tape underneath the header rail pressed against the top of the front upper surface of the tub. Locate each end of the assembly with even gaps to both sides of the tub.

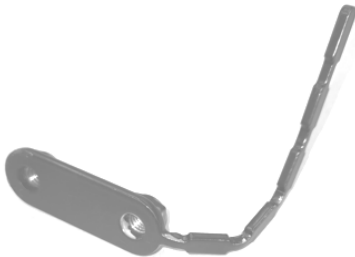
3.8) Fit between the cabin and the tub the nut plate (4655378) to align to the two holes in the corners of the tub. The end of the nut plate may be bent to a shape to provide access for fitment. Place masking tape on the back of the cabin before it is inserted to prevent scratching the cabin's paint work.

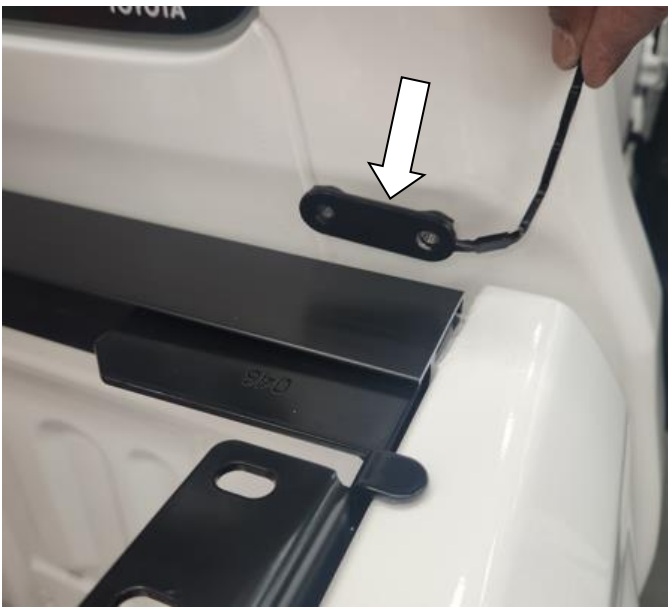
Bend down in  
behind vehicle tub  
("A")

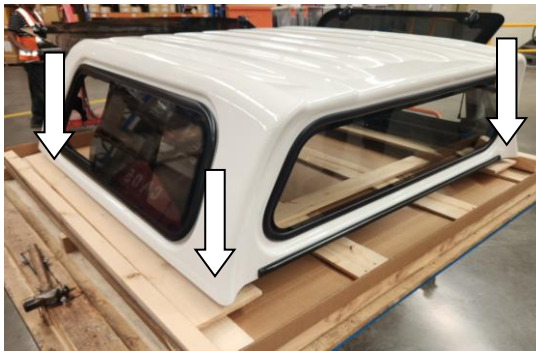
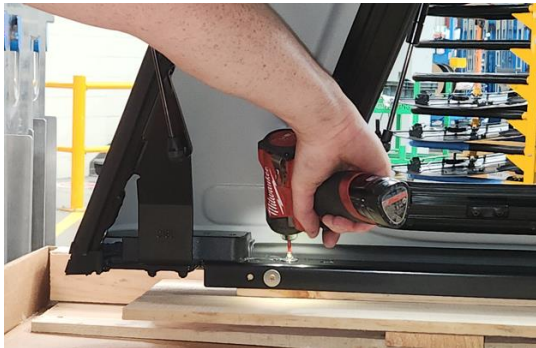
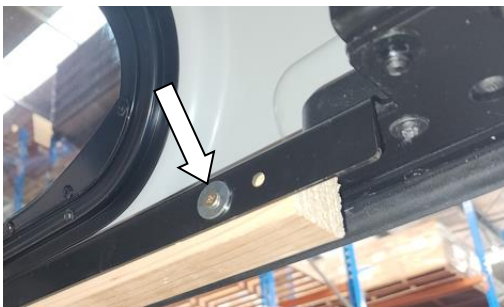
4.0) Unscrew the canopy on the pallet by removing the four wood screws in each corner holding the canopy down through the top of the base rails to the pallet. Gain access to screws via opening the rear door and via side lift up windows.

4.1) Also remove the four screws holding the four timber bearers on the inner flange of the base rails.

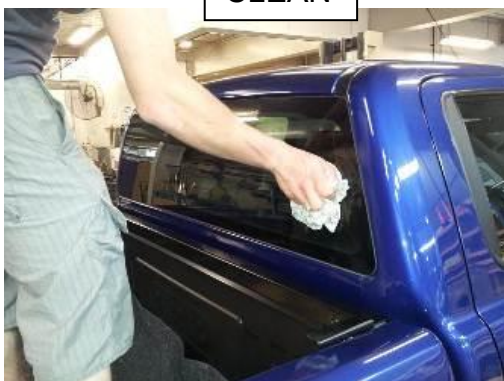
4.2) Clean the front window of the canopy on the outside.

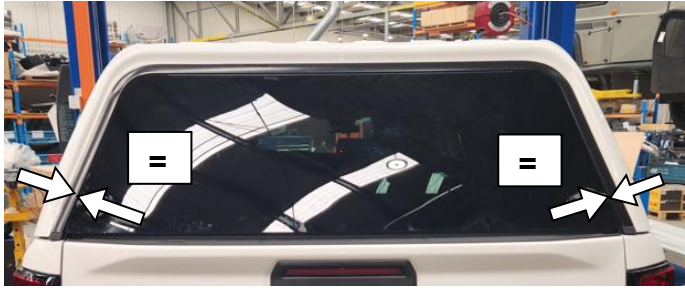
- 4.7) Stand back and walk around the canopy and check uniform balanced fit to the tub and cabin.
- The canopy is central on the Ute body.
  - Alignment between cab and canopy is even both sides.
  - The rear door seals against the tailgate cap evenly both sides without excessive force on glass to close.
  - **The gap is even between the door glass to the frame on both sides at 5 to 7mm.**
  - The gap of the door glass lower edge has gap to the tailgate cap to open.

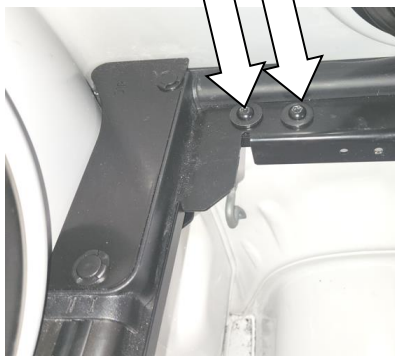
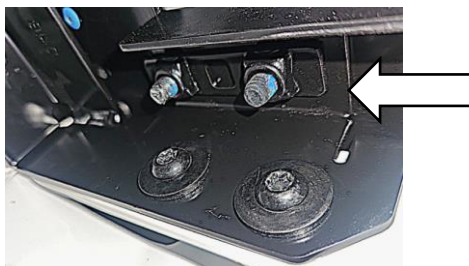
M8X25 TORX SCREWS (6151625) WITH M8x25.4x3 28 WASHER (4581303) ABOVE AND (667AQ024) 40MM PITCH NUT PLATE ON THE UNDERSIDE

- 4.8) On the inner edge of the front corner of the base rail inside the canopy, assemble two M8x25mm Torx head screws (6151625) with two M8x25.4x3mm washers (4581303) down in through the top of the base rail and through the two holes in the front corner mount bracket (667PD046R). On the underside use **the 40mm pitch nut plate** (667AQ024). **Tighten the M8 Torx screws to 20Nm.**

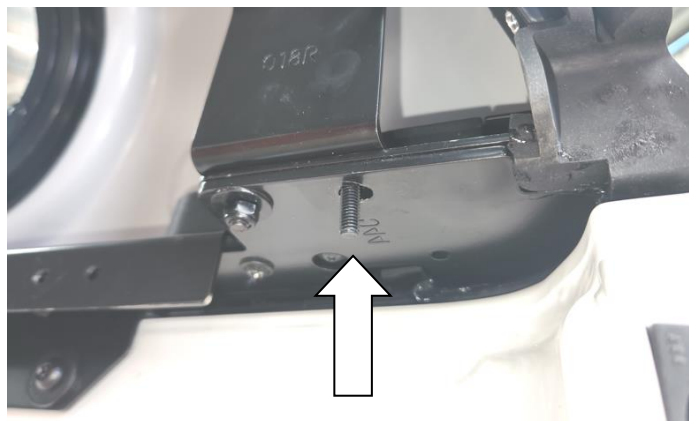
- 4.15) Open the tailgate. Inside the canopy's rear corner on the right-hand side, remove the bolt through the door frame support bracket and the canopy base rail in the rearmost location and replace it with M6 x 30mm long hex bolt (6151228) and retained washer. Retain the other washers and discard the M6 nyloc nuts. Both Sides.

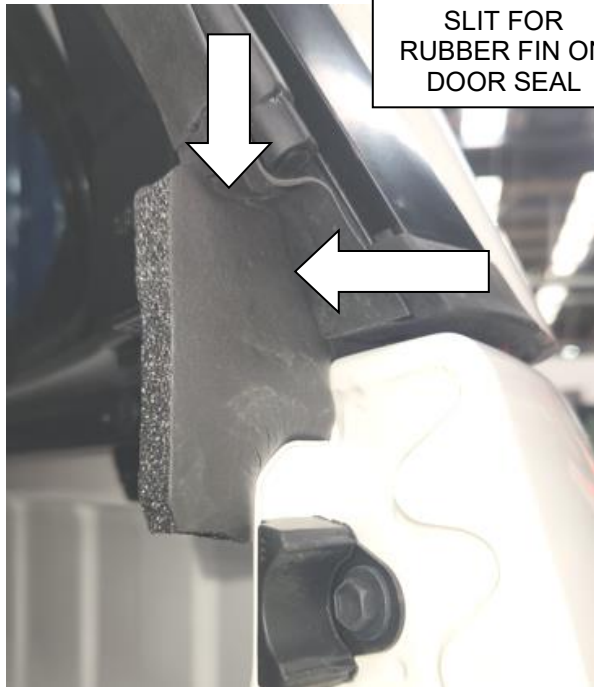
4.19) Adhere the rear face of the foam pad to the front face of the rubber door frame corner seal, ensuring the corners of the foam pad butt up to the corners of the door frame seal.

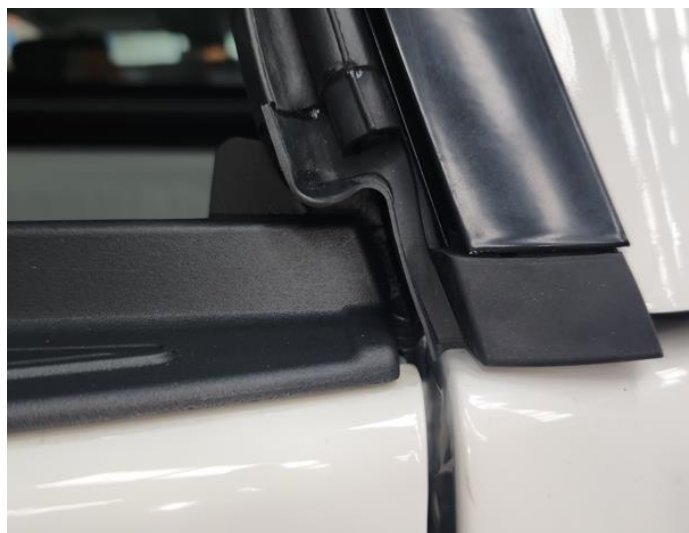
- 4.22) Close the tailgate to check the foam compression to the tailgate. Check the tailgate can be closed without excessive force to close it against the seal compression. Also check the foam pad seals up to the back of the plastic tailgate cap.

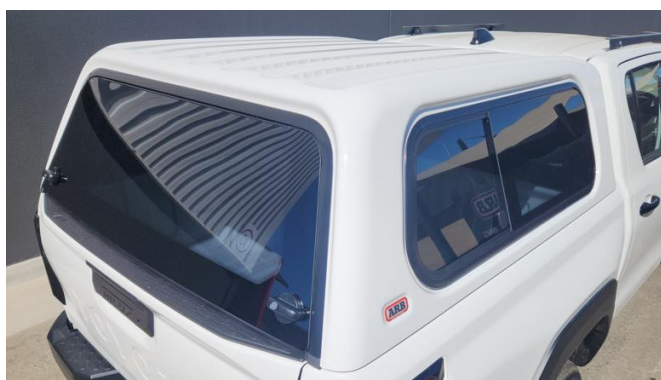
4.25) Water test the canopy around all windows and joins to the tub with high pressure hose and seal or report any leaks found.

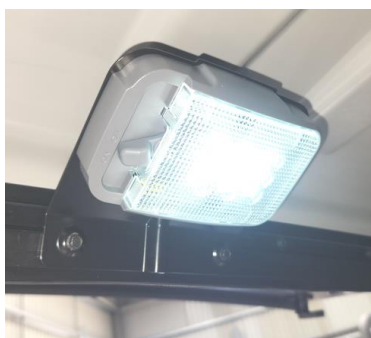
5.0) Check the interior light works when turned on via the switch. The light is battery operated with four AA batteries which can be accessed via removing the lens.
